Site Environmental Report Pantex Plant 2009

September 2010

U.S. Department of Energy/National Nuclear Security Administration
Pantex Site Office

Environmental Stewardship Department,
Waste Operations Department,
and The Projects Division

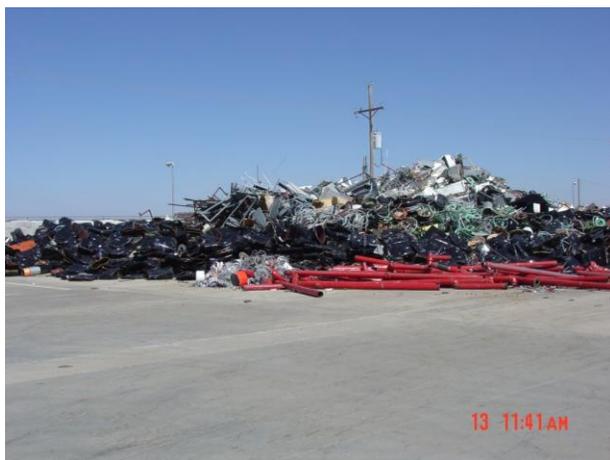
FIGURE 3.7 – Accumulation of Scrap Metal

In 2000, the DOE suspended the unrestricted release of scrap metal from radiological areas for recycling. Pantex’s conservative approach applied a Pantex-specific definition of radiological area. Over an eight year period, approximately 537,000 lbs of scrap metal were accumulated at the site. This resulted in the accumulation of a large pile of scrap metal (Figure 3.7). With the volume of metal coming to a critical point and with an identified need to improve the management of scrap metal, efforts were taken by the Pantex team to reevaluate the conservative approach used in the application of the scrap metal suspension.

A plan was developed to address the historical inventory of metal held since the start of the suspension in 2000. This plan was implemented in a coordinated effort between the Pantex's Waste Operations Department personnel, Radiation Safety Department personnel, and the current contracted recycling company. Through this extensive effort, approximately 90% (492,520 lbs) of the accumulated scrap metal being released was shipped offsite for recycling. A total of 44,298 lbs of suspension-impacted scrap metal remained on-site for further evaluation or further guidance from DOE-Headquarters on handling and disposition.

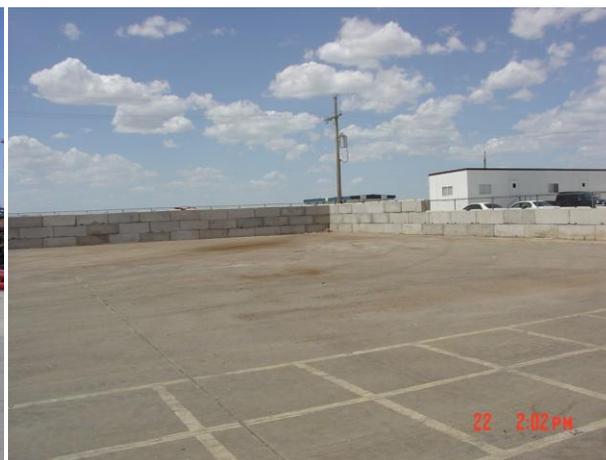
FIGURE 3.8 – After Recycling of Scrap Metal

Through the efforts of this Pantex team in preventing disposal of nearly 500,000 lbs of metal, valuable landfill space was saved and recycling was enhanced. This resulted in a cost savings of \$140,000 and generated revenue of over \$34,000. By recycling the eight year accumulation, 1,782 ft² of space was freed up to be used for other projects (Figure 3.8).

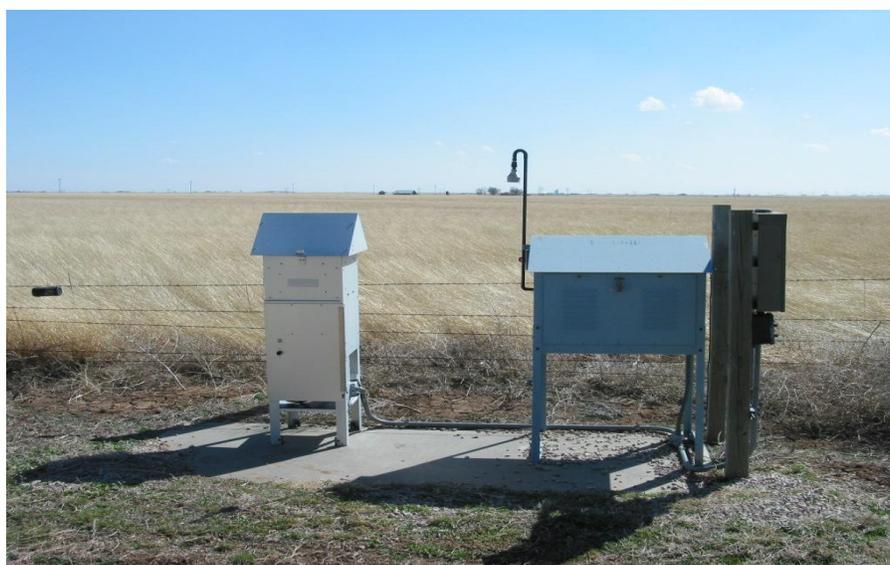
FIGURE 5.3 – Typical Air Monitoring Site

Each monitoring station was equipped with a high-volume air sampler and a low-volume air sampler (See Figure 5.3). At far-left is a container for the co-located TLD discussed in Chapter 4. The high-volume sampler is located on the left and a “doghouse” containing the low-volume sampler on the right.) The samplers (when operated) ran continuously, and filters or silica gel samples were collected from the samplers on a (nominally) weekly basis. Operational characteristics of the samplers, such as the length of the sample collection period (known as the “run time”), the beginning and ending flow rates, and other parameters were recorded by the sampling technicians at the initiation and/or at the completion of the sampling activity.

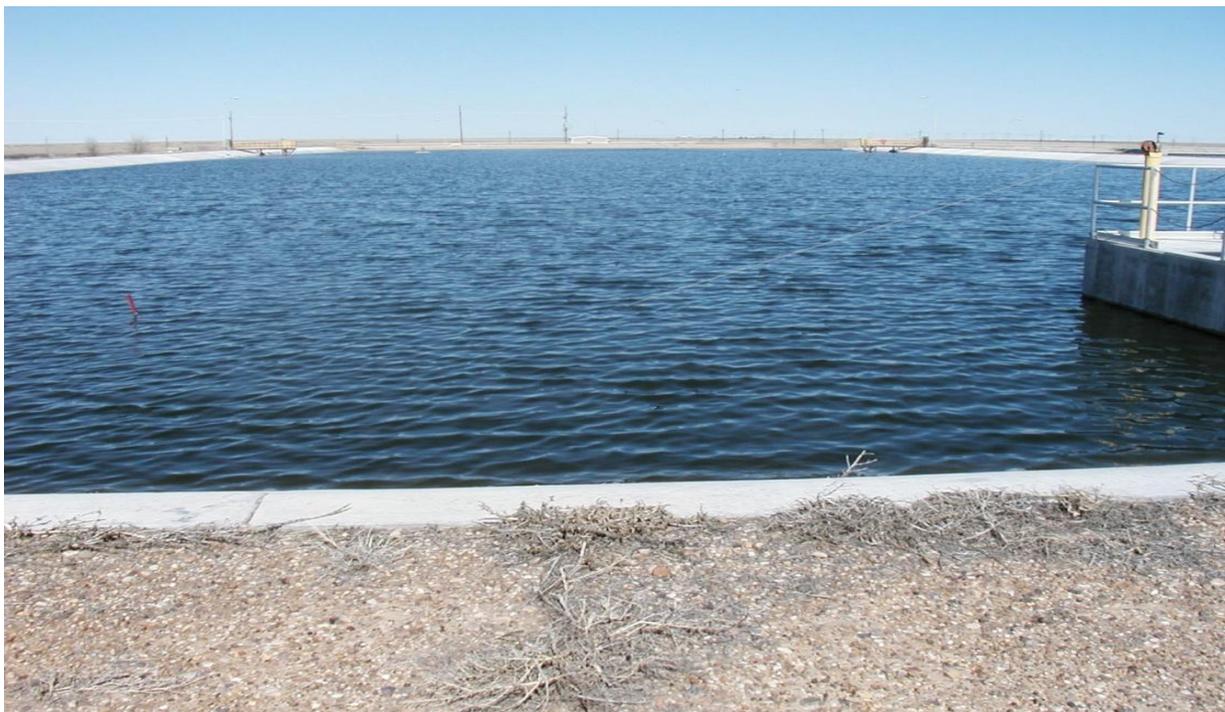
The WWTF (Figure 8.1) is a clay-lined, facultative lagoon that covers approximately 1.58 hectares (3.94 acres) and has a capacity of 42 million liters (11 million gallons). Pantex also has two storage lagoons used for storage and retention of treated wastewater. The east lagoon is a storage lagoon with a polyethylene liner that covers an area the same size as the facultative lagoon and can serve as the facultative lagoon should the need arise (Figure 8.2).

FIGURE 8.1 — Wastewater Treatment Facility, Facultative Lagoon

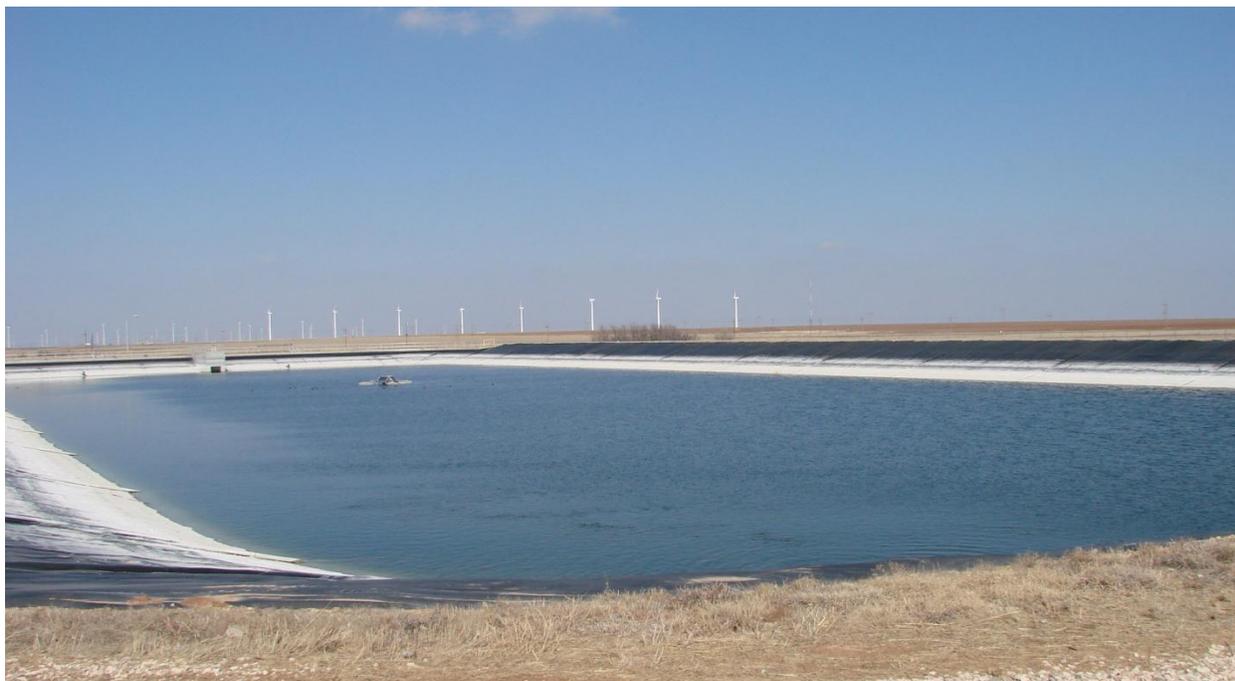
FIGURE 8.2 — Wastewater Storage Lagoon

The northern storage lagoon is a clay-lined lagoon, which covers approximately 1.05 hectares (2.6 acres) and has a capacity of 25.54 million liters (6.74 million gallons). This lagoon is used only for the storage of treated wastewater.

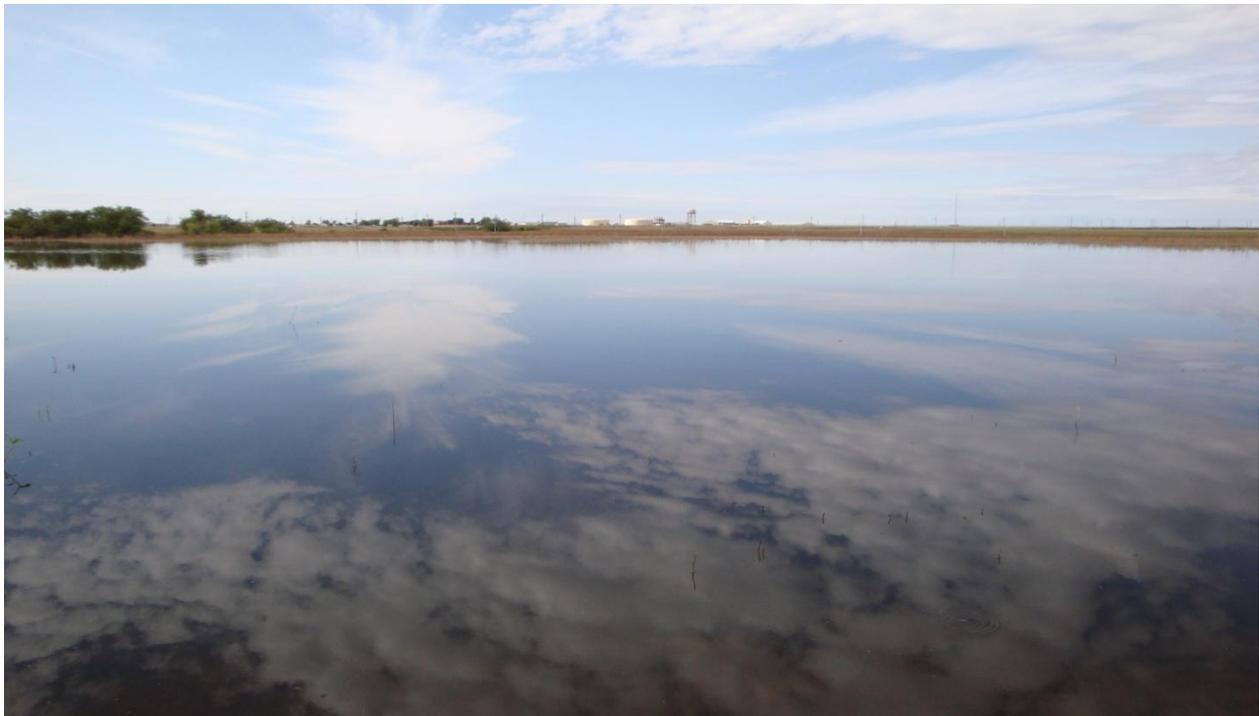
FIGURE 9.1 — *A Playa Lake at Pantex Plant*

Pantex Plant has a semi-arid climate and is located in a region of relatively flat topography. Surface water represented by rivers or streams does not exist around the facility site; all surface water drains to isolated playa lakes (Figure 9.1). Playa lakes are a unique topographic feature in the Texas Panhandle. They are shallow, ephemeral lakes that have clay-lined basins that fill periodically with surface water runoff. There are approximately 20,000 playas on the southern high plains. Playa lakes are extremely important hydrologic features that provide prime habitat for wildlife, especially waterfowl that winter in the southern High Plains. Playas are also believed by most authorities to be an important source of recharge for the Ogallala Aquifer, the area's primary source of groundwater.

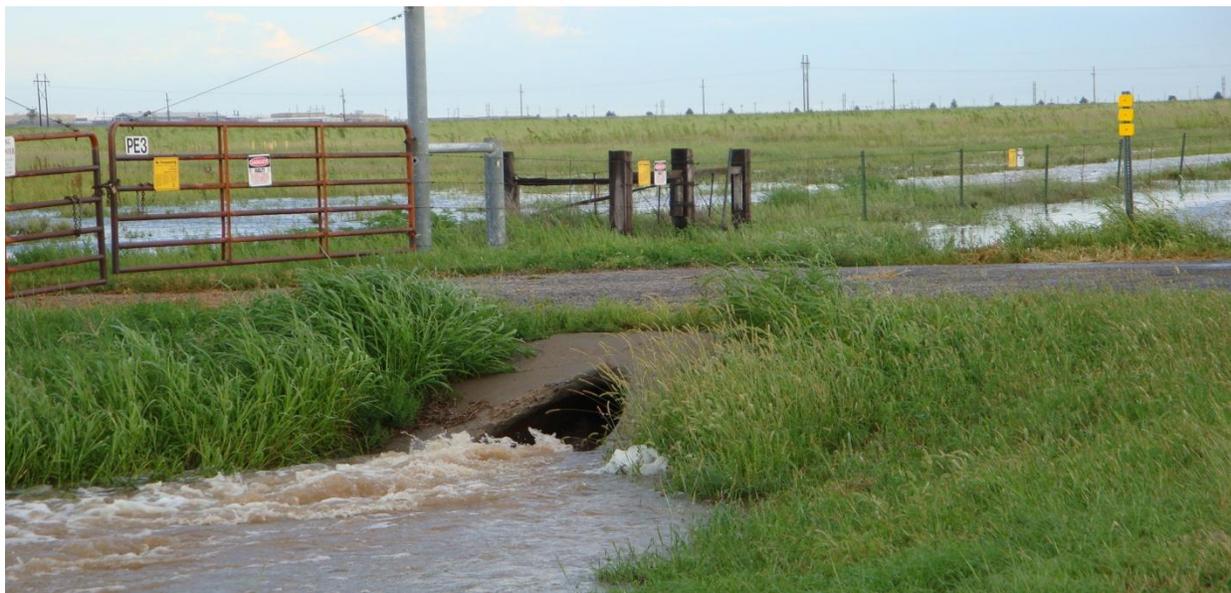
FIGURE 9.3 — Storm Water Discharging at Pantex Plant

Storm water runoff at Pantex Plant is sampled in accordance with the Texas Pollutant Discharge Elimination System (TPDES) Multi-Sector General Permit (MSGP) for storm water. The MSGP was issued in August of 2006. B&W Pantex filed for coverage under the MSGP in November of 2006. The permit expires in August 2011. Storm water sampling locations, known as "outfalls," are conveyances in which storm water accumulates and discharges (Figure 9.3). Locations have been selected based on their proximity to operational areas of the Plant.

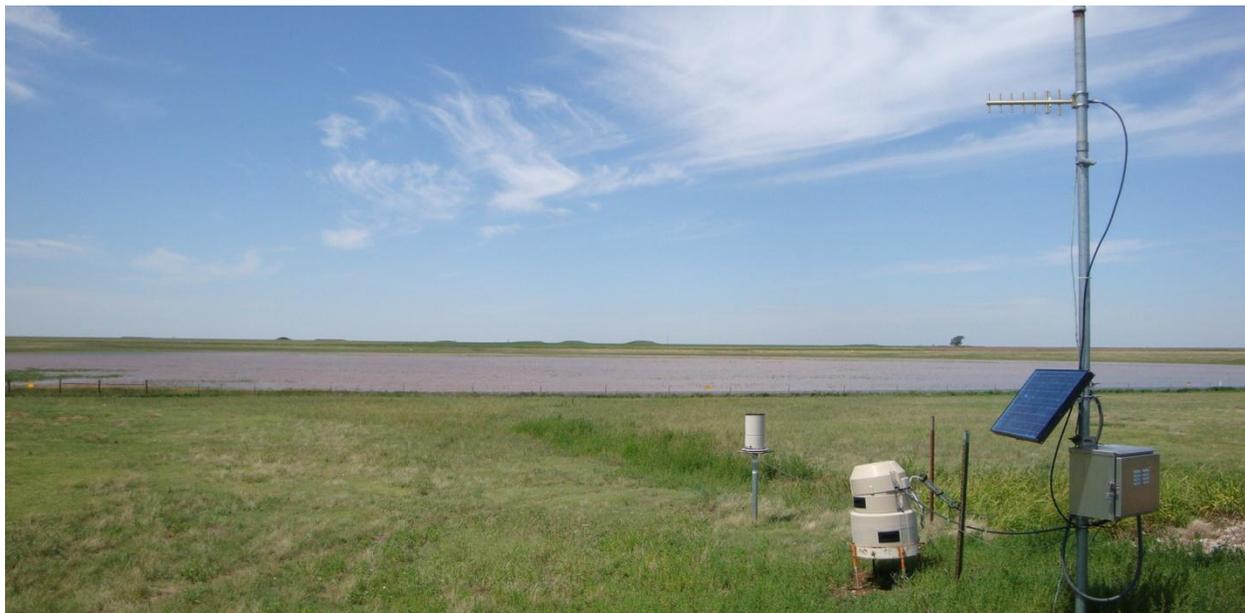
FIGURE 9.6 — *Monitoring Equipment at STORM 07; Playa 3 in Background*

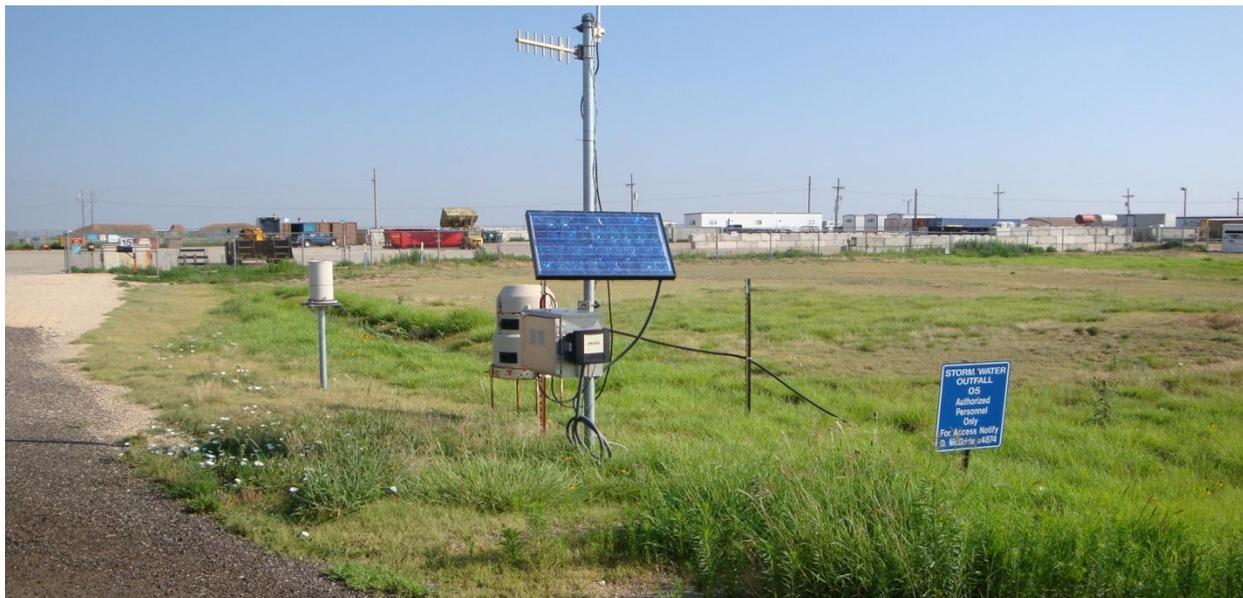
FIGURE 9.7 — *Monitoring Equipment at STORM 05; Waste Staging Area in Background*

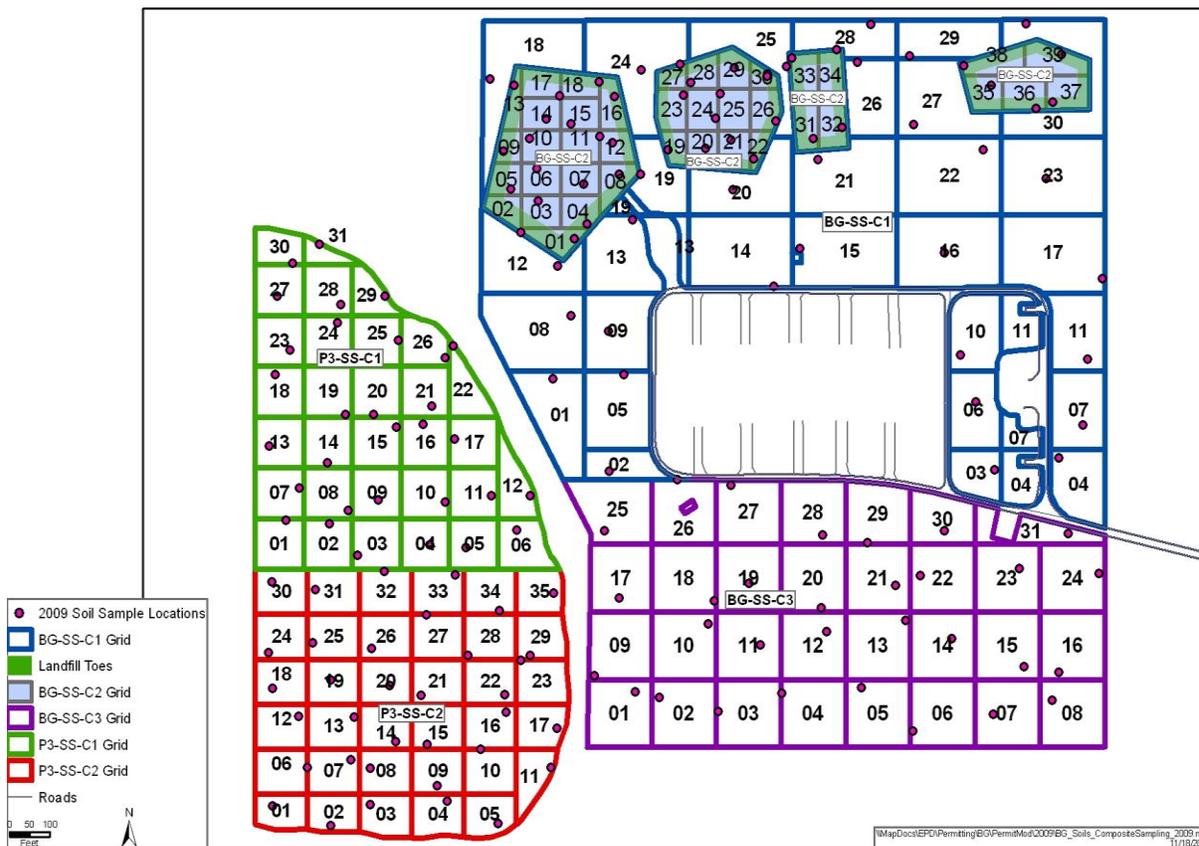
FIGURE 10.1 — Burning Ground Multi-Incremental Soil Sampling Locations for 2009

In 2009, soil samples were collected from two general landscape positions: playa bottoms and interplaya uplands. The characteristic soil types for these landscape positions are Randall clay in playas, and Pullman clay loam in the uplands. Samples for non-radiological analyses were collected as sub-samples from the first 2-inches depth from each associated grid area, and composited to form individual samples (Figure 10.1).
