# Site Environmental Report Pantex Plant

For Calendar Year 2010

# Site Environmental Report Pantex Plant 2010

September 2011

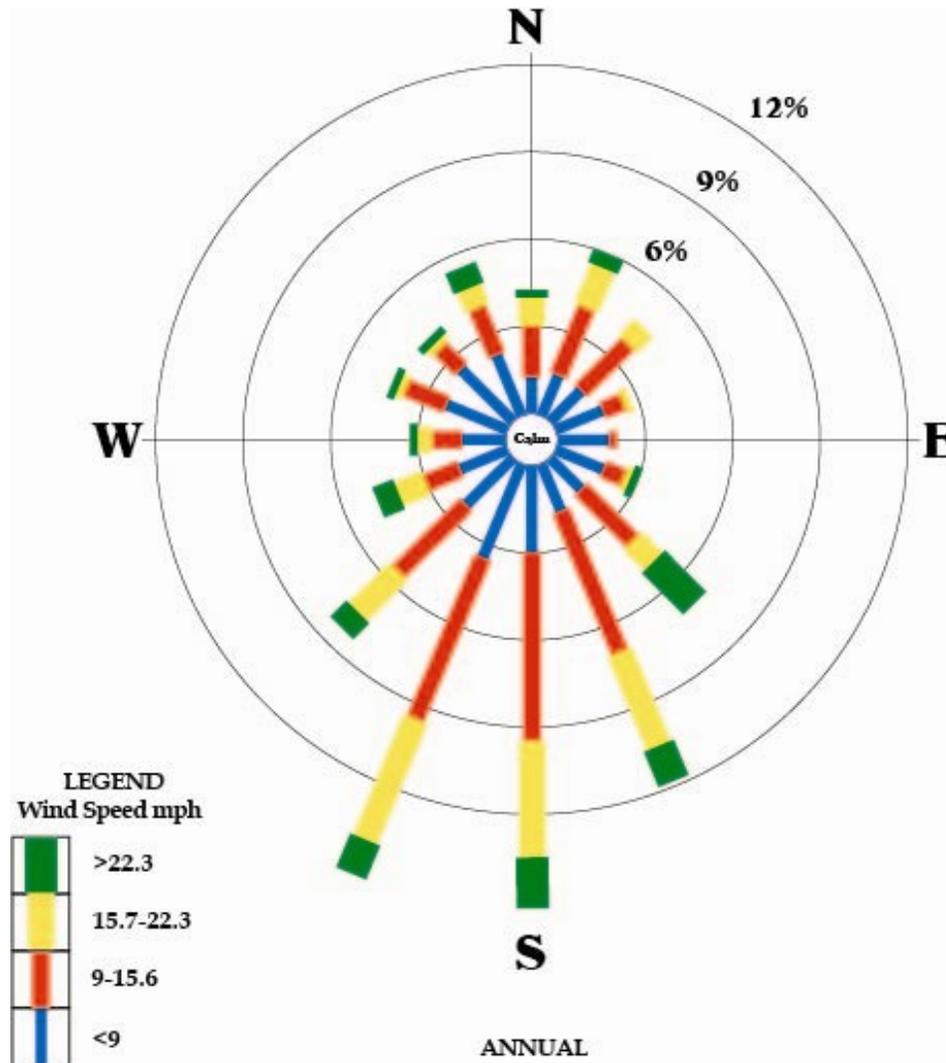
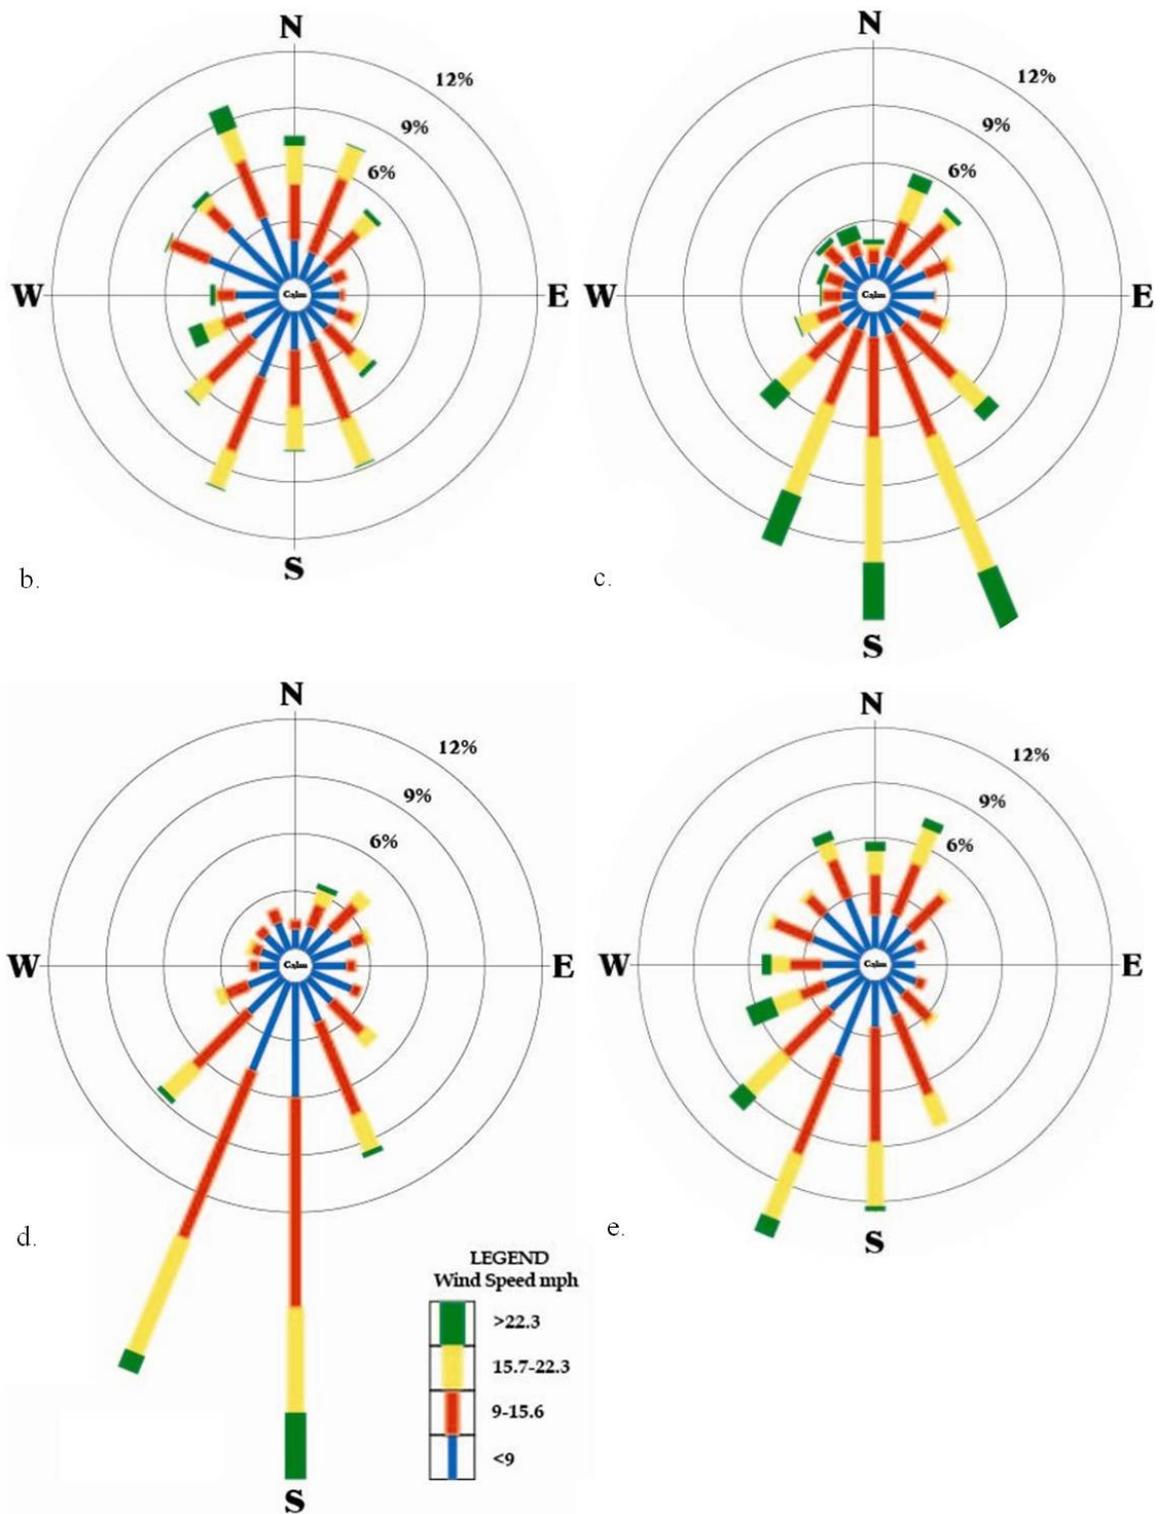
FIGURE 1.3(a) — *Pantex Plant Wind Roses for 2010 (a) Annual*

percentage (nearly 50 percent) of the winds blew from the southeast through southwest during the year. Figure 1.3 also shows that wind direction and speed frequencies vary by season: Northwesterly winds are most frequent during the period from January 1 through March 31 (roughly corresponding to “winter”) (Figure 1.3[c]). Wind direction frequency is more bi-modal during the periods from April 1 through June 30 (Figure 1.3[d]) and from October 1 through December 31 (Figure 1.3[e]) (“spring” and “fall” respectively). The vast majority of winds are from the southern sector in “summer” (i.e., July 1 through September 30), including over 40 percent from the south and south-southwest directions (Figure 1.3[b]). In addition, wind speeds are highest in winter and spring and lowest in summer and autumn.

FIGURE 1.3(b-e) — Pantex Plant Wind Roses for 2010 (b) 1<sup>st</sup> Quarter; (c) 2<sup>nd</sup> Quarter; (d) 3<sup>rd</sup> Quarter; and (e) 4<sup>th</sup> Quarter

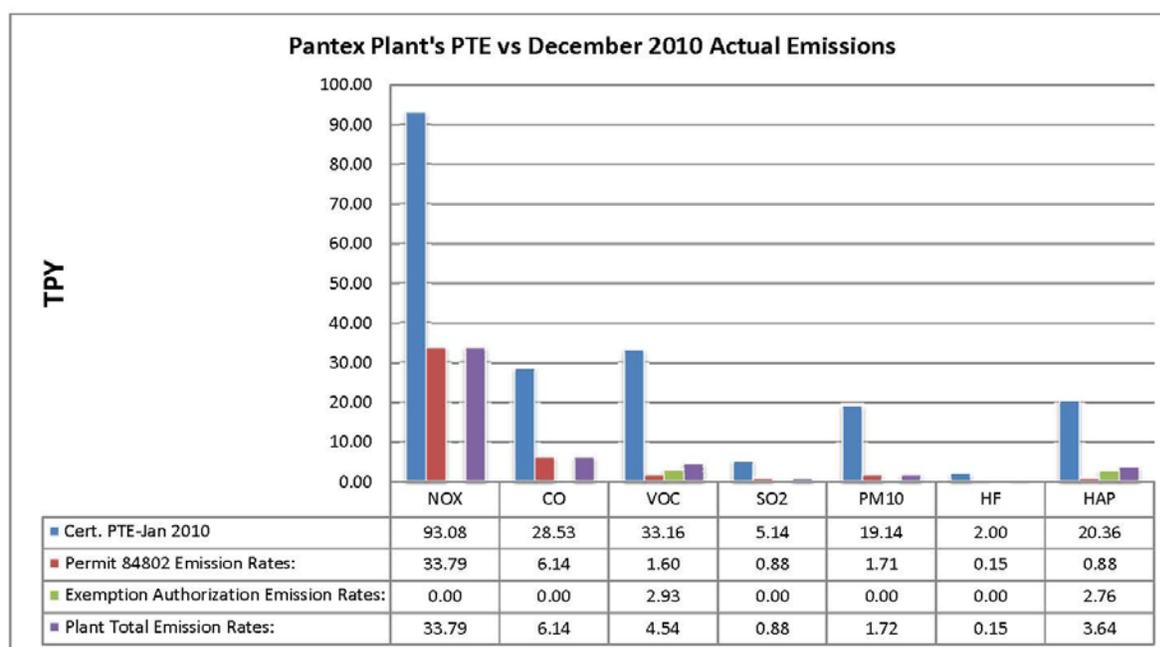
**FIGURE 2.1 — PTE versus Actual Yearly Emissions**

Over the 12 months of air emission tracking for 2010, operations at the Pantex Plant remained well below the certified and authorized PTE levels for each of the pollutants tracked. Figure 2.1 below is a graphic presentation of the emission information gathered from January through December 2010, expressed in relation to the PTE certification in Tons per Year. Figure 2.1 is a demonstration that Pantex Plant continues to meet the requirements of the Title V program for the designation as a Synthetic Minor Source.

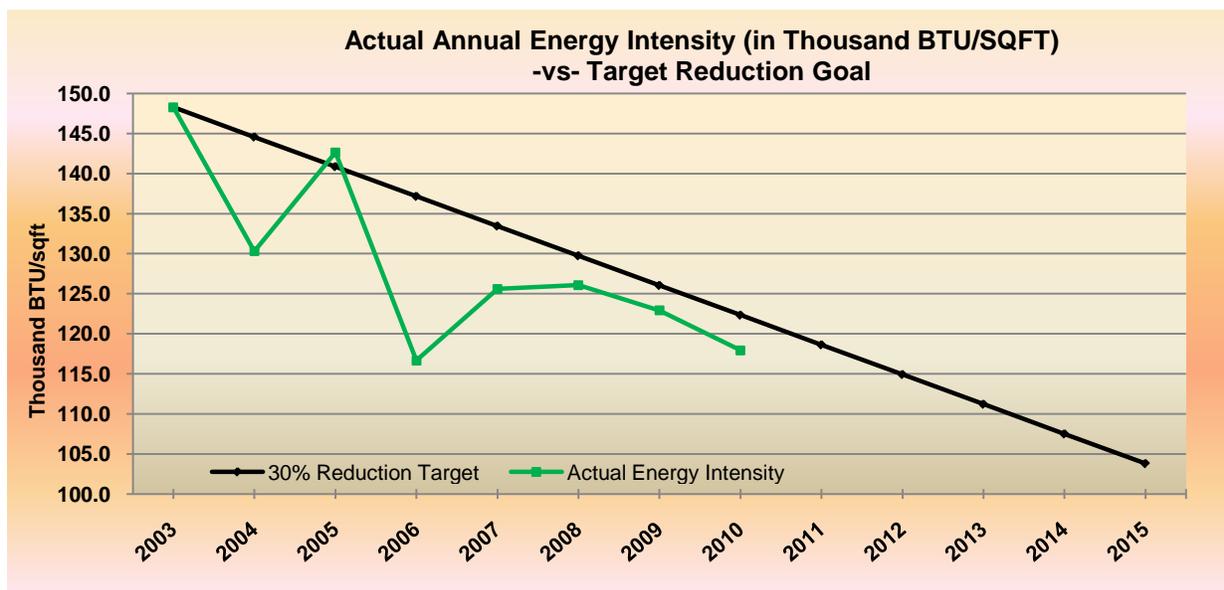
FIGURE 3.3 — Energy Use versus Required Target Reduction Rate

To date, Pantex Plant has been successful in reducing energy intensity compared to the FY 1985 baseline. From the early days of energy management, the Plant has reduced energy intensity at least 40 percent. Executive Order 13423 mandates Pantex to reduce energy intensity by 30 percent by the end of FY 2015, relative to the required baseline of the agency's energy use in FY 2003 (Figures 3.3). Total plant energy use continues to exhibit a downward trend as energy cost shows signs of stability (Figure 3.4). Presently the Plant maintains a 20 percent reduction in energy intensity from the 2003 baseline in anticipation of achieving the reduction goal.

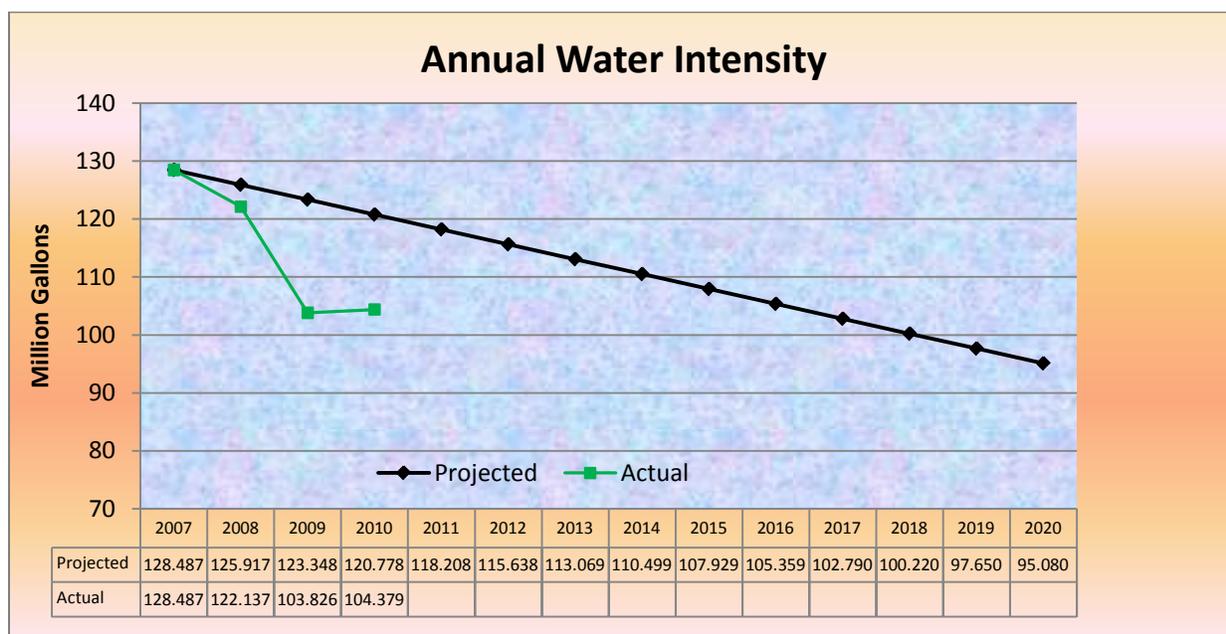
**FIGURE 3.6 - Actual Water Use versus Required Target Reduction Rate**

Executive Order 13423 required Pantex, beginning in FY 2008, to reduce water consumption intensity relative to the baseline of the agency’s water consumption in FY 2007. The challenge was to focus on awareness and life-cycle cost-effective measures to reduce annual use by 2 percent through the end of FY 2015 (16 percent). Executive Order 13514 (2009) progressively challenged facilities to increase the goal by reducing an additional 10 percent by 2020, equating to 26 percent. Pantex has currently reduced water consumption by approximately 19 percent and is engaged to meet the cumulative goal. (Figure 3.6)

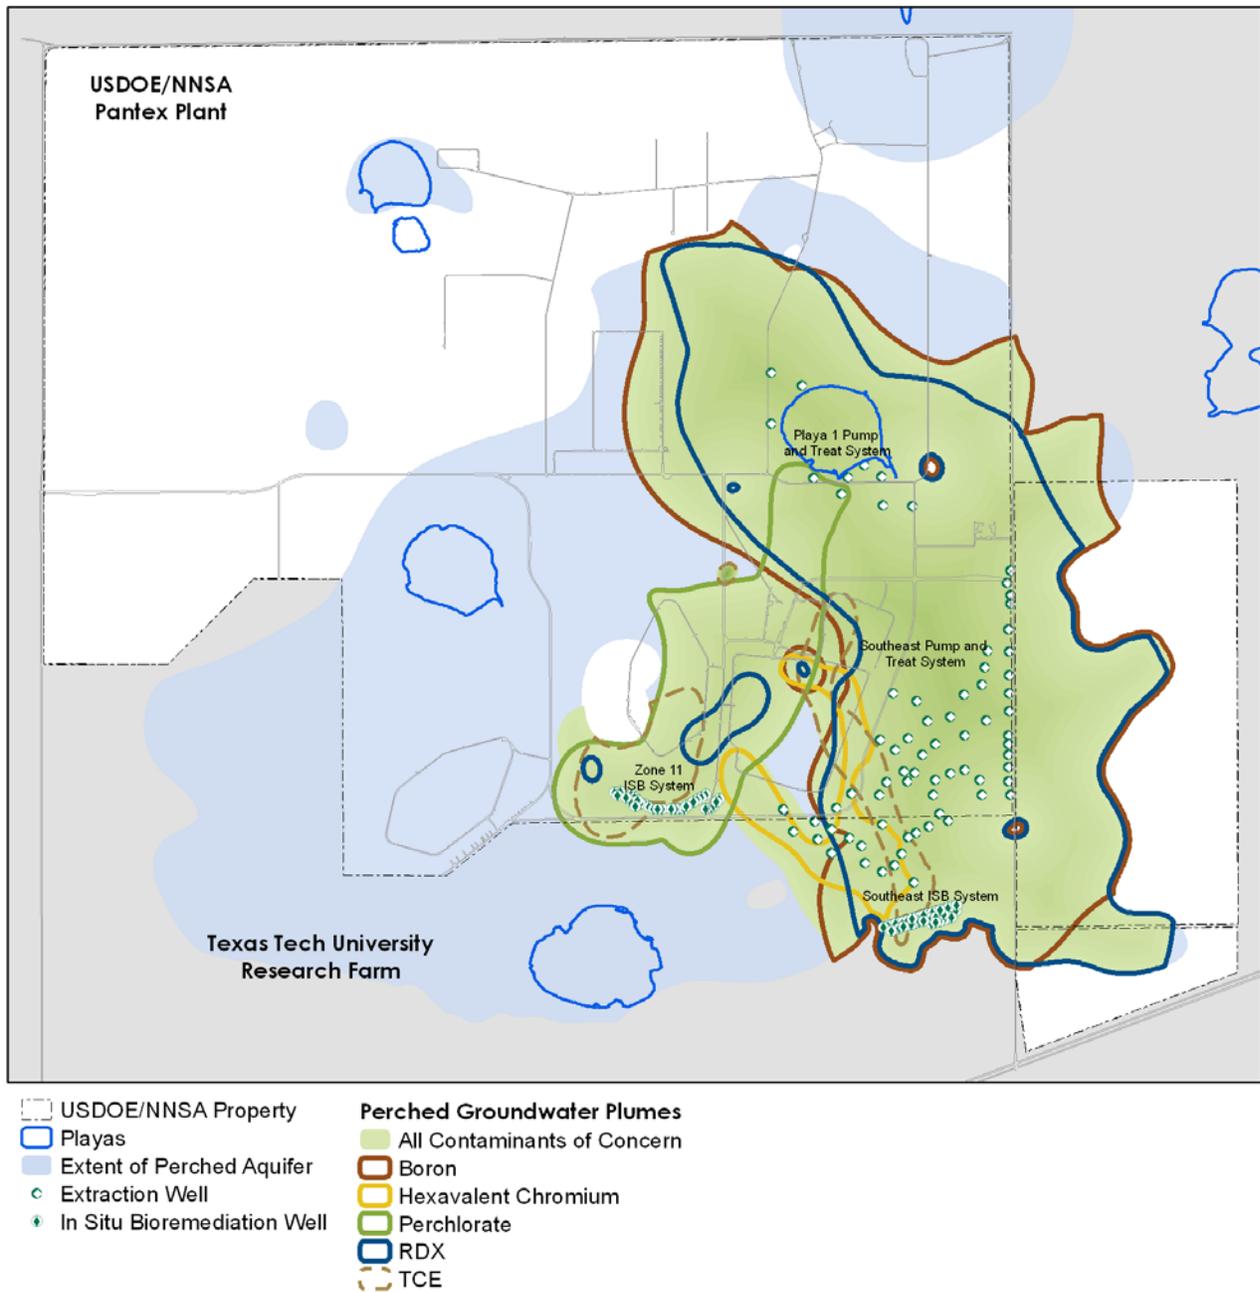
**FIGURE 3.21 - Perched Groundwater Plumes and Treatment Systems**

(P1PTS) was started in late 2008, and the system became fully operational in January 2009.

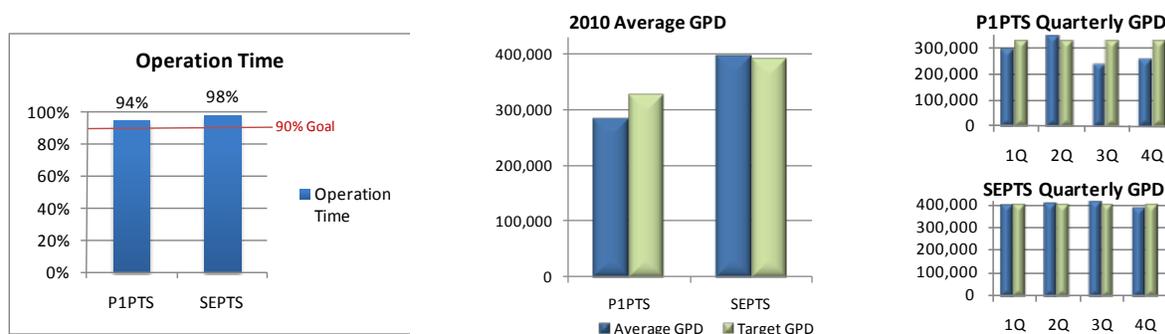
FIGURE 3.22 – Pump and Treat Systems Performance

To reach the goal of reducing saturated thickness, the Pump and Treat Systems have a goal of operating 90% of the time and at 90% of treatment capacity. The Pump and Treat Systems performance for 2010 is depicted in Figure 3.22. The SEPTS exceeded the operational and treatment goal for 2010 by operating 98% of the time and treated an average of 393,468 gallons per day (gpd) (91% of capacity) of impacted perched groundwater. The P1PTS operated 94% of the time and treated an average of 281,974 gpd (78% of capacity) during 2010. As depicted in Figure 3.22, system treatment performance was continuous at the SEPTS, but treatment declined at P1PTS in the last half of 2010. The decline in performance was due to the upgrade to the irrigation system which required the WWTF and portions of the irrigation system to be shut down for short periods of time.

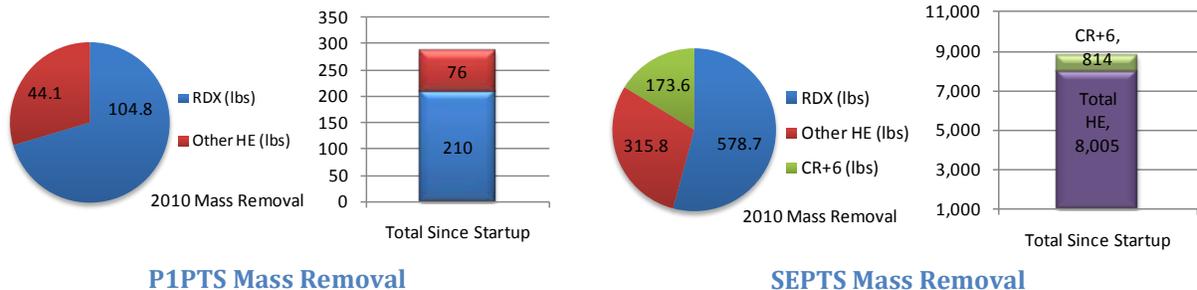
**FIGURE 3.23 – Pump and Treat Systems Mass Removal**

In addition to removing impacted water from the perched aquifer, the pump and treat systems remove contaminant mass from the groundwater that is extracted from the aquifer. The P1PTS primarily removes the high explosive RDX and the SEPTS primarily removes RDX and hexavalent chromium (Cr<sup>+6</sup>). Figure 3.23 provides the mass removal for HEs and chromium for 2010, as well as totals since startup of the systems. The SEPTS has been operating longer, and the greatest concentrations of HEs are found in the SEPTS extraction well field, so mass removal is much higher at that system.

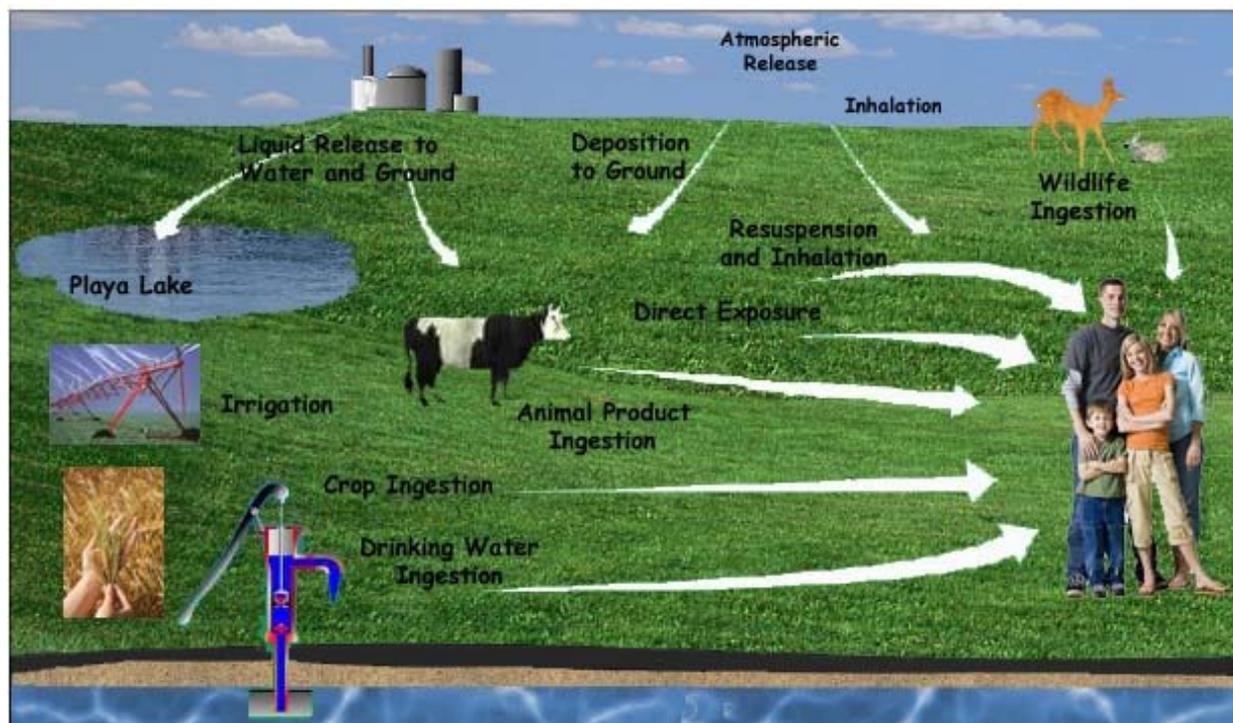
**FIGURE 3.25— Potential Pathways for Environmental Transport of Contaminants**

characterize and respond to releases from DOE activities; assess impacts and characterize exposures and doses to individual members of the general public, to the population, and to biota in the vicinity of the Pantex Plant; and demonstrate compliance with applicable regulatory and permit limits. The potential pathways along which contaminants could travel are illustrated in Figure 3.25.

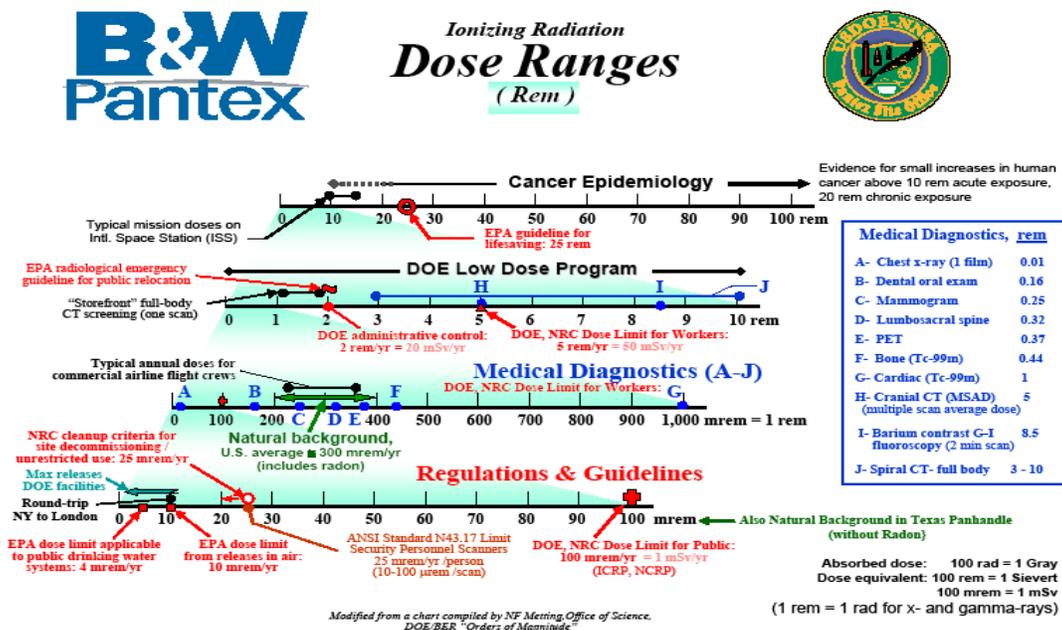
FIGURE 4.1 – Comparison of Ionizing Dose Ranges

(NCRPb). A comparison of the dose rates from several sources is illustrated at Figure 4.1. The Pantex doses are several orders of magnitude smaller than the smallest doses illustrated.

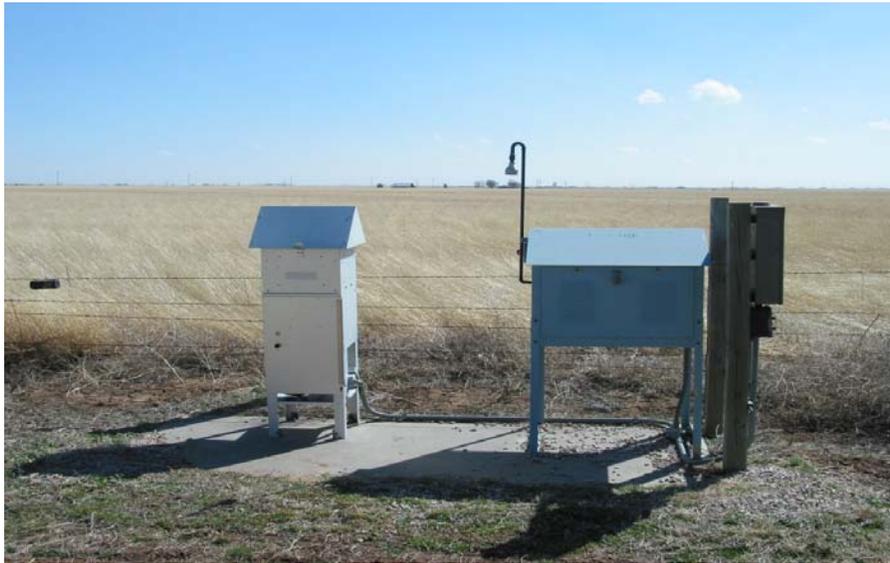
**FIGURE 5.3 – Typical Air Monitoring Site**

Each monitoring station was equipped with a high-volume air sampler and a low-volume air sampler (See Figure 5.3). At far-left is a container for the co-located thermoluminescent dosimeters (TLD) discussed in Chapter 4. The high-volume sampler is located on the left and a “doghouse” containing the low-volume sampler on the right. The samplers (when operated) ran continuously, and filters or silica gel samples were collected from the samplers on a (nominally) weekly basis. Operational characteristics of the samplers, such as the length of the sample collection period (known as the “run time”), the beginning and ending flow rates, and other parameters were recorded by the sampling technicians at the initiation and/or at the completion of the sampling activity.

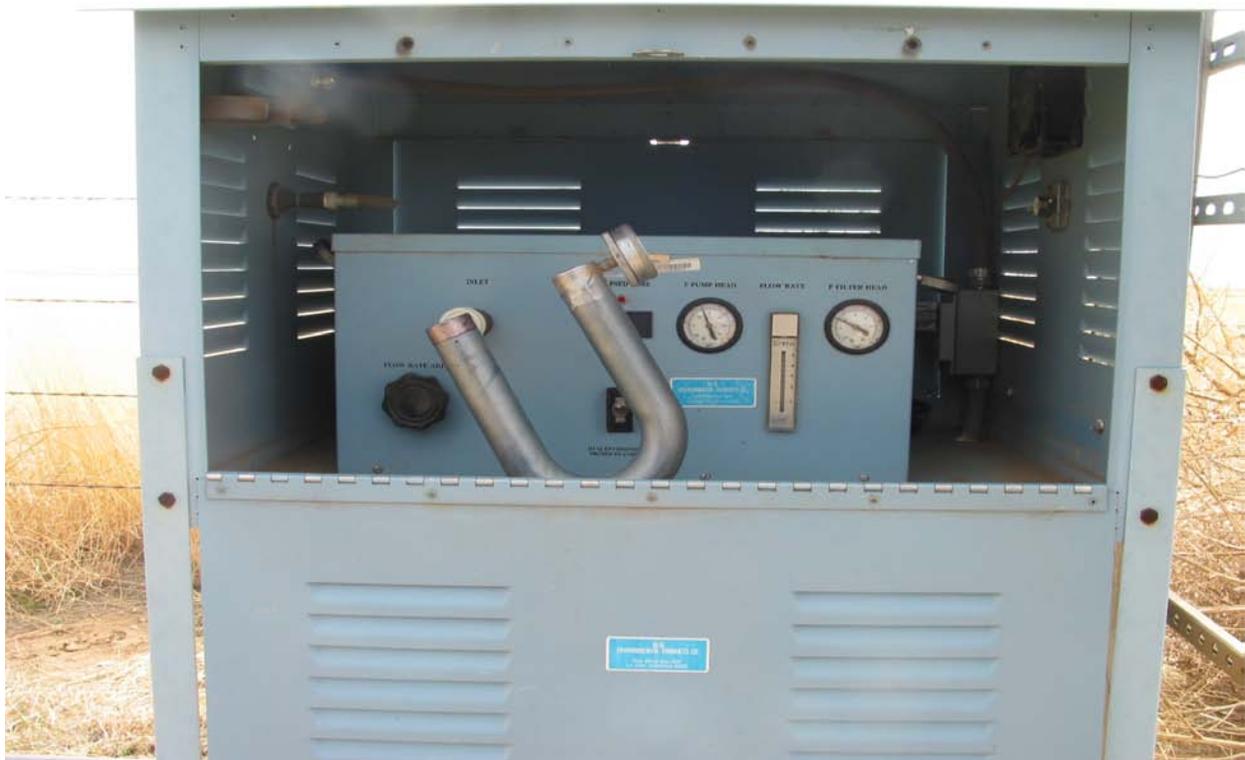
**FIGURE 5.4 – Low-Vol Sampling Apparatus**

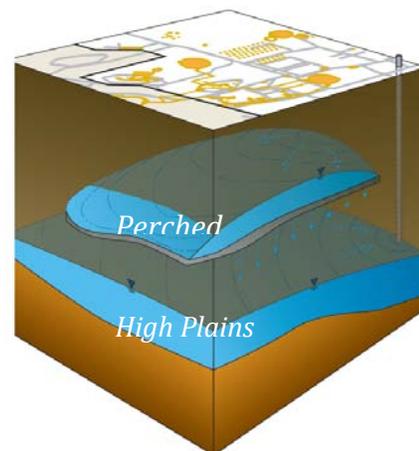
**FIGURE 6.1 – Groundwater Beneath Pantex**

The second water-bearing zone, known as the High Plains Aquifer, is located below the fine-grained zone in the Ogallala and Dockum Formations. The High Plains Aquifer is a primary drinking and irrigation water source for most of the High

Plains. The groundwater surface of the High Plains Aquifer beneath the Plant is approximately 400-500 feet below ground surface; saturated thickness is approximately 1 to 100 feet in the southern regions of the Plant and approximately 250 to 400 feet in the northern regions. In the vicinity of the Plant, the primary flow direction of the High Plains Aquifer is north to northeast due to the influence of the City of Amarillo's well field located north of the Plant.

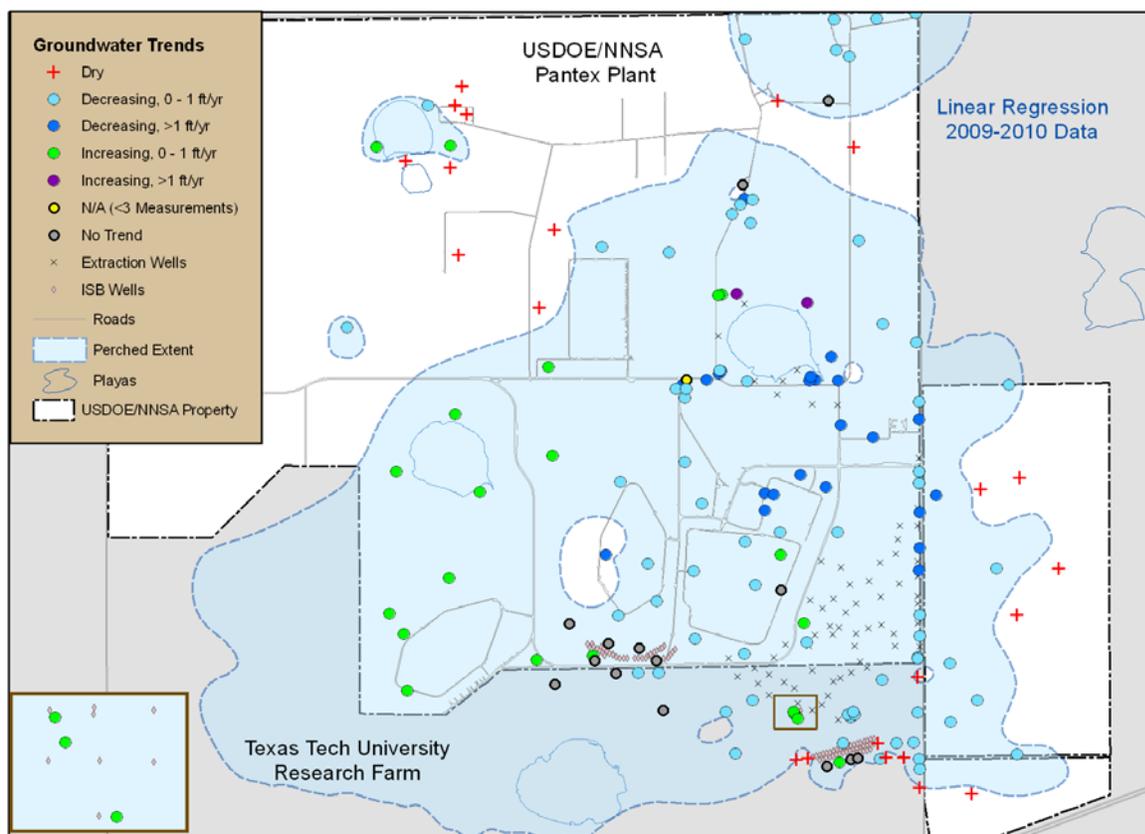
FIGURE 6.3 – Water Level Trends in the Perched Aquifer

- Four wells north of Playa 1 exhibited increasing trends in water levels. These increasing trends may have been caused by recharge in the area due to historic rainfall events and episodes of flooding. In addition, three of these wells are under the influence of the PIPTS and likely have variable water levels.

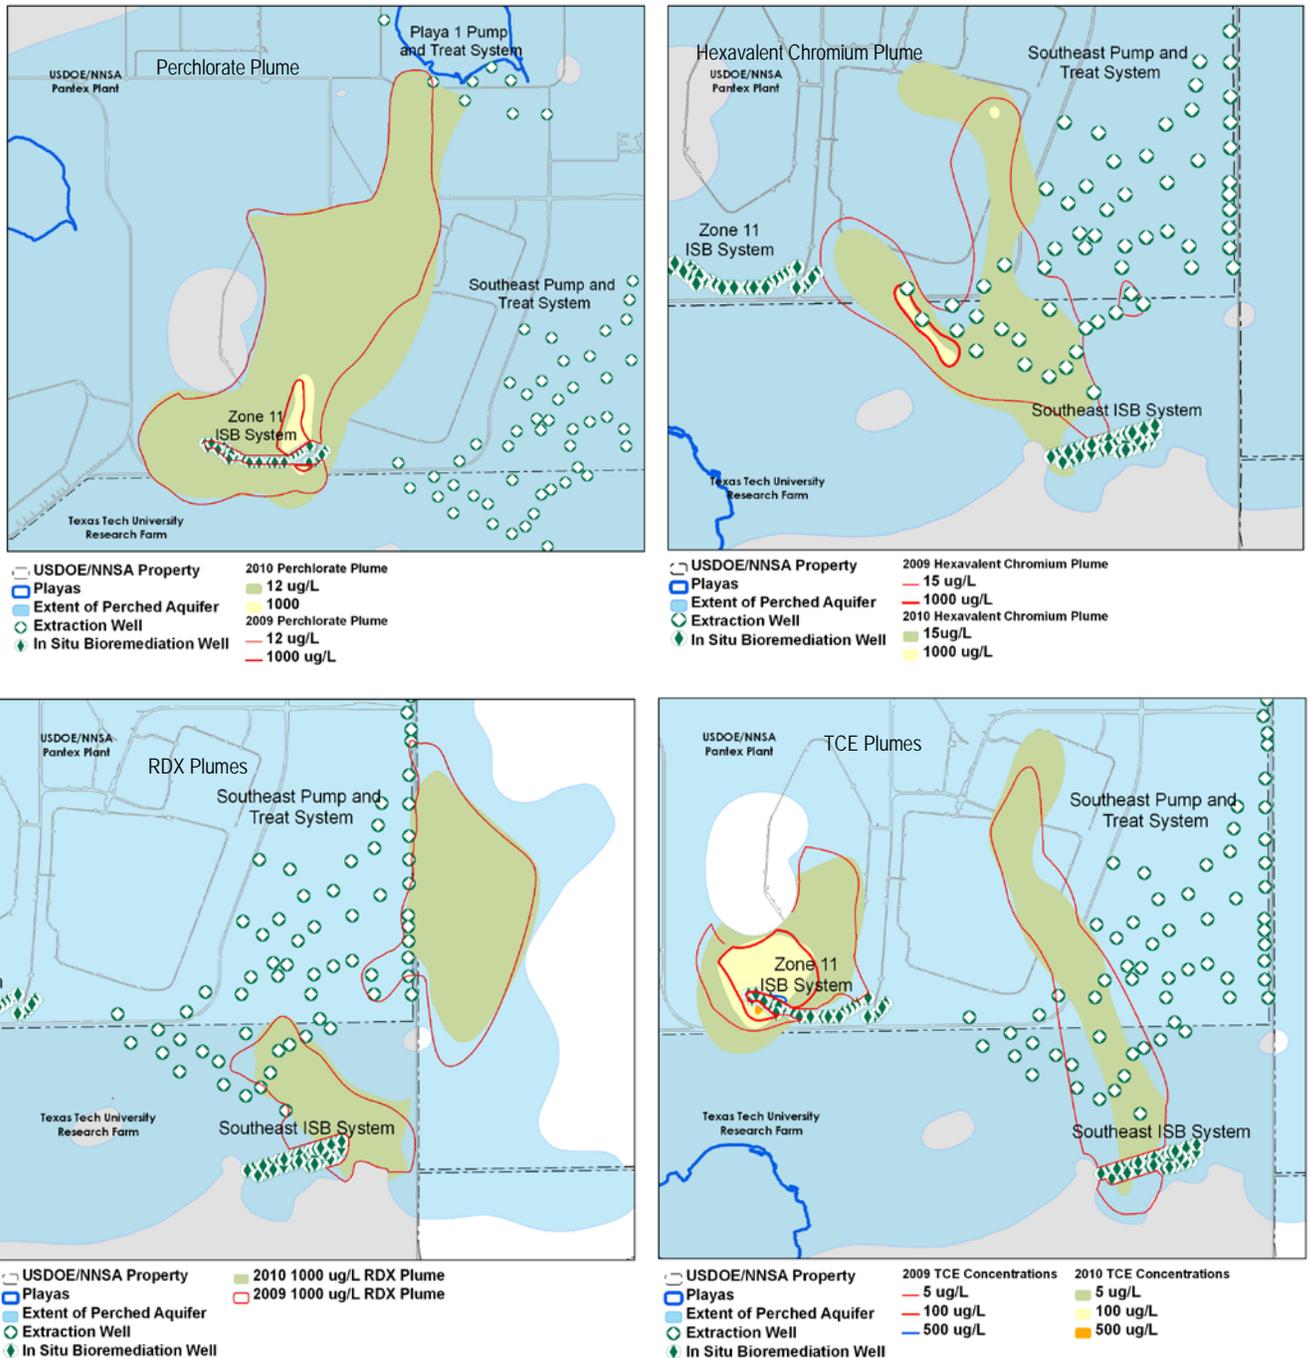
FIGURE 6.4 – 2009-2010 Plume Movement - Perchlorate, Hexavalent Chromium, RDX, and TCE

field. However, concentrations tend to be variable in this area, so additional data are needed to confirm this plume movement.

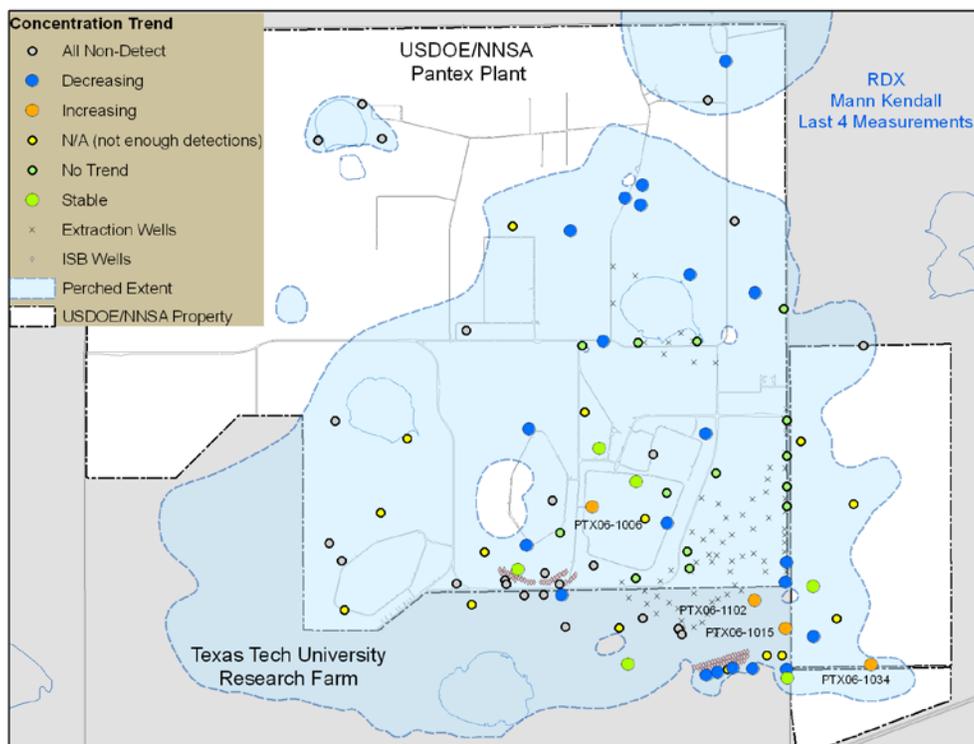
**FIGURE 6.5 –RDX Concentration Trends in the Perched Aquifer**

established an adequate reducing zone for the contamination that is present, based on geochemical conditions monitored at the treatment zone and results of monitoring.

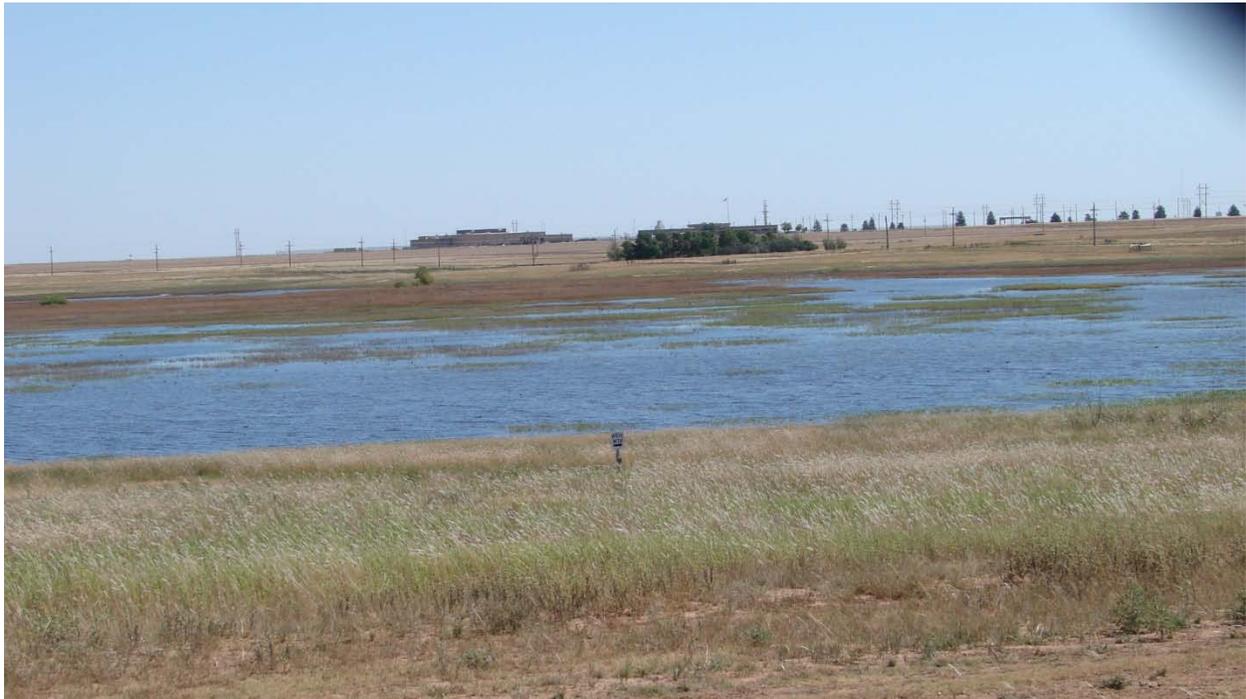
**FIGURE 8.1 — Playa 1**

Domestic and industrial wastewaters generated at Pantex Plant are treated in an onsite Wastewater Treatment Facility (WWTF). Industrial effluents from plant operations are generally pre-treated and are directed into the WWTF for further treatment. All such effluents are collected in the sanitary sewer, managed in the WWTF, and are either disposed through a permitted outfall<sup>1</sup> to an underground irrigation system or discharged to an onsite playa lake through the permitted outfall. The playa is an ephemeral lake and is not connected to any other lakes, rivers, or streams (Figure 8.1).

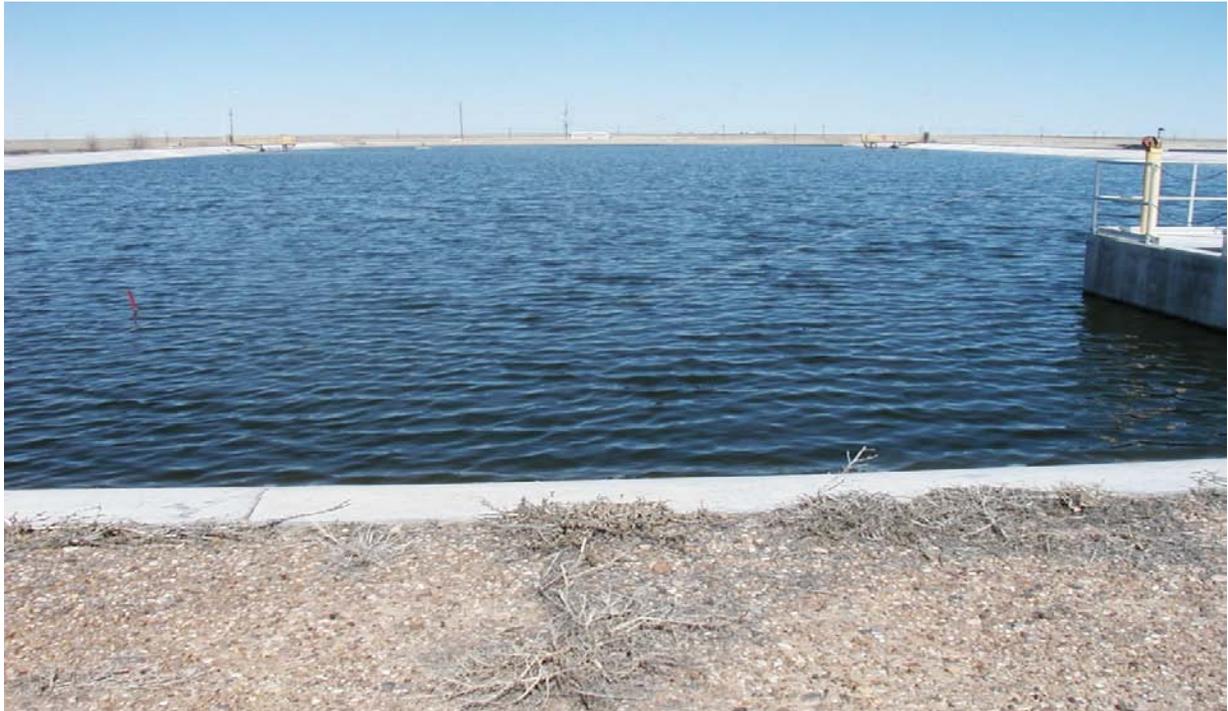
**FIGURE 8.2** — *Wastewater Treatment Facility, Facultative Lagoon*

The WWTF (Figure 8.2) is a clay-lined, facultative lagoon that covers approximately 1.58 hectares (3.94 acres) and has a capacity of 42 million liters (11 million gallons). Pantex also has two storage lagoons used for storage and retention of treated wastewater. The east lagoon is a storage lagoon with a polyethylene liner that covers an area the same size as the facultative lagoon and can serve as the facultative lagoon should the need arise (Figure 8.3).

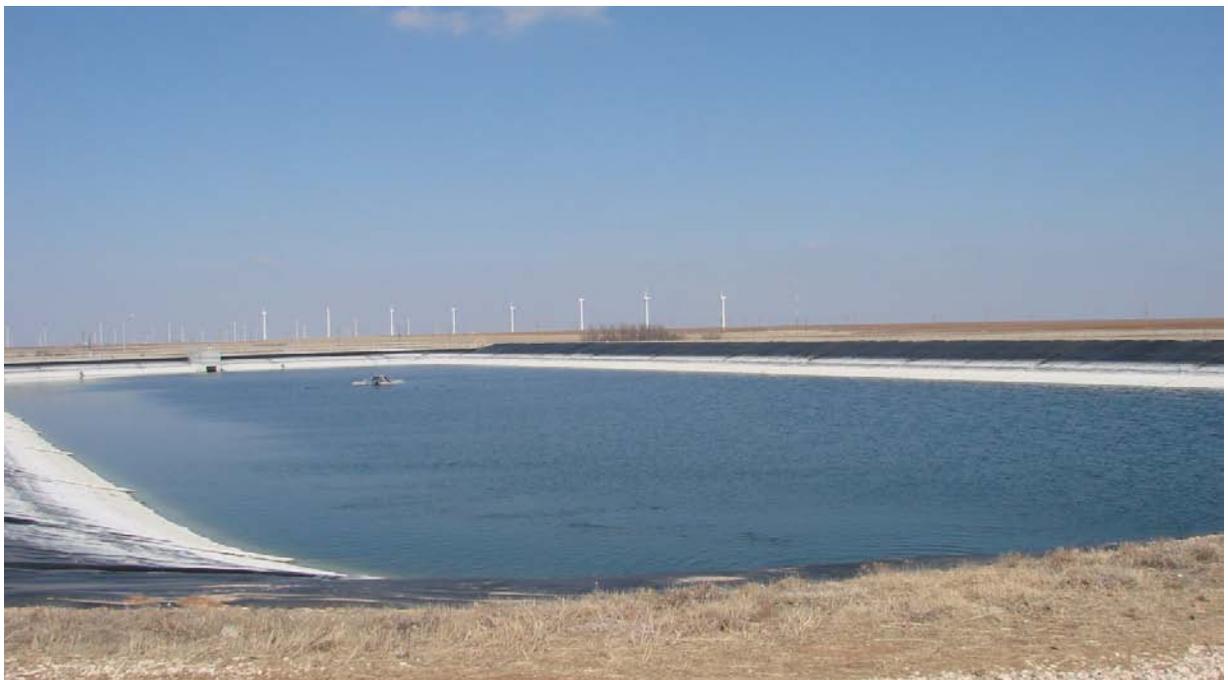
**FIGURE 8.3** — *Wastewater Storage Lagoon*

The northern storage lagoon is a clay-lined lagoon, which covers approximately 1.05 hectares (2.6 acres) and has a capacity of 25.54 million liters (6.74 million gallons). This lagoon is used only for the storage of treated wastewater.

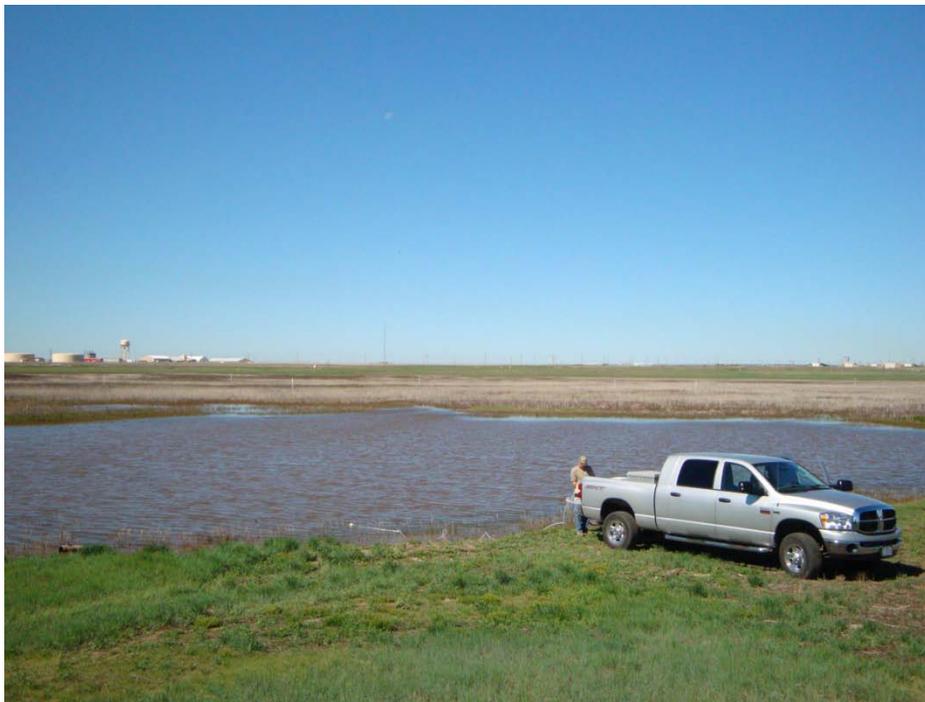
**FIGURE 9.1** — *Surface Water Sampling at Playa 1*

Pantex Plant is located in a region of relatively flat topography and with a semi-arid climate. Surface water represented by rivers or streams does not exist around the facility site; all surface water drains to isolated playa lakes (Figure 9.1). Playa lakes are a unique topographic feature in the Texas Panhandle. They are shallow, ephemeral lakes that have clay-lined basins that fill periodically with surface water runoff. There are approximately 20,000 of these playas on the southern high plains. Playa lakes are extremely important hydrologic features that provide prime habitat for wildlife, especially waterfowl that winter in the southern High Plains. Playas are also believed by most authorities to be an important source of recharge for the Ogallala Aquifer, the area's primary source of groundwater.

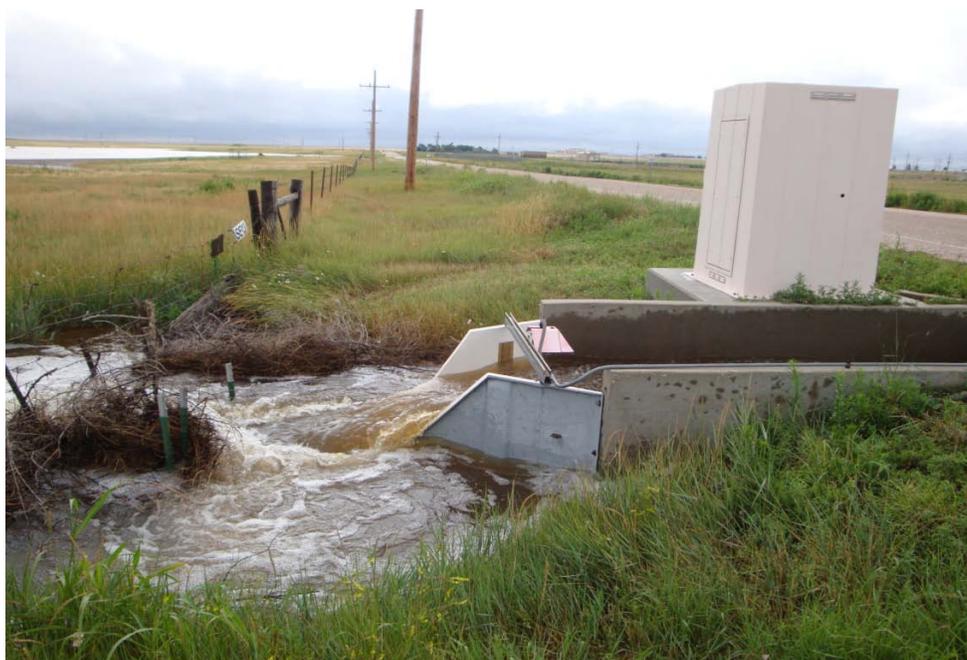
**FIGURE 9.3 — Storm Water Discharging at Pantex Plant**

Storm water runoff at Pantex Plant is sampled in accordance with the Texas Pollutant Discharge Elimination System (TPDES) Multi-Sector General Permit (MSGP) for storm water. The MSGP was issued in August of 2006. B&W Pantex filed for coverage under the MSGP in November of 2006. The permit expires in August 2011. Storm water sampling locations, known as “outfalls,” are conveyances in which storm water accumulates and discharges (Figure 9.3). Locations have been selected based on their proximity to operational areas of the Plant.

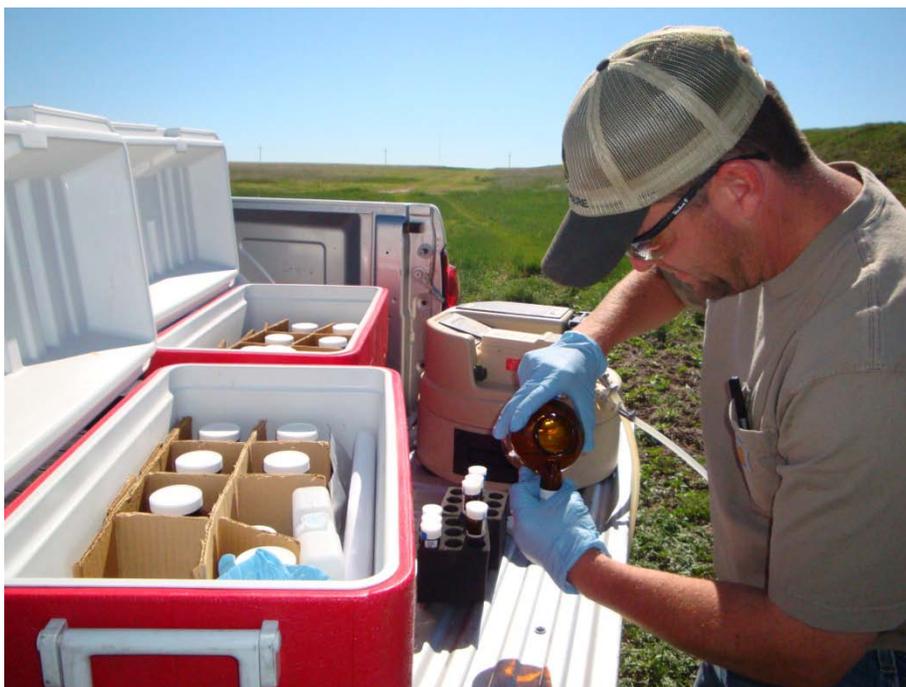
**FIGURE 9.5 — Sampling at Playa 1**

Playa 1 was sampled in the second and third quarters during 2010 for metals, VOCs, SVOCs, explosives, and radionuclides (Figure 9.5). Metals analyses in 2010 at Playa 1 were all consistent with historic levels found at the playa and all were below the IWQPs. VOCs and SVOCs were below their respective PQLs. Radiological sampling conducted at Playa 1 during 2010 involved co-sampling with the TDSHS during the month of April and again in July. Tritium was below the MCL for drinking water. Isotopic radiological analyses for uranium and plutonium were below the DCGs for ingested water.

During the second quarter, the explosives HMX and RDX were both detected at 0.001 mg/l, slightly above their PQLs (0.0005 mg/l). These explosive detections have occurred at similarly low levels at Playa 1 in past years.

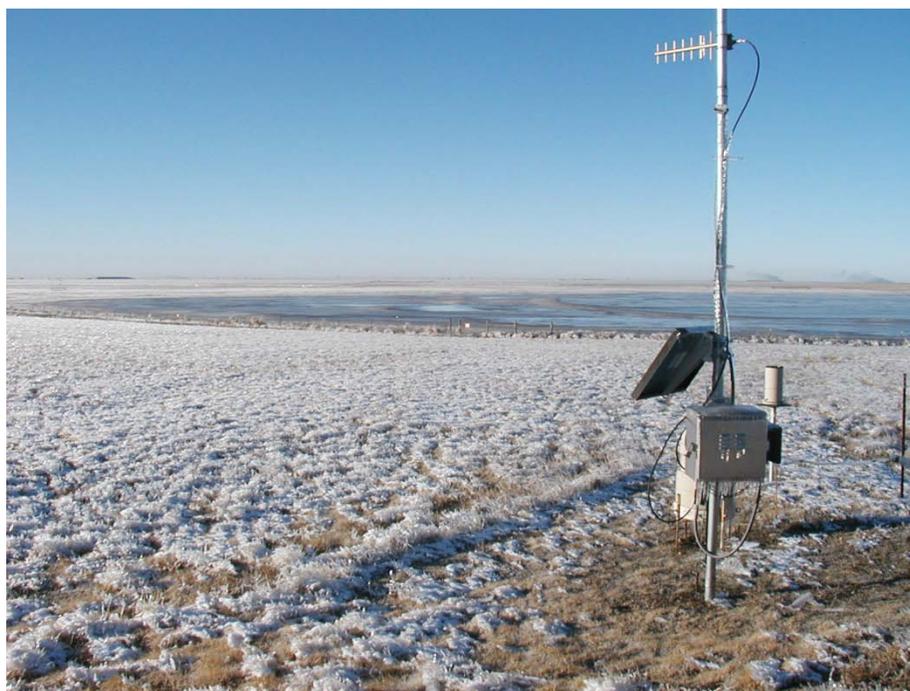
**Storm Water Outfall 07—Burning Ground.** This outfall receives only storm water runoff, primarily as sheet flow, from the Burning Ground operational area. For this reason, sampling at the outfall can be a challenge. The drainage area is primarily grassland, and the outfall is located between the Burning Ground to the northeast and Playa 3 to the southwest (Figure 9.6).

**FIGURE 9.6 — Monitoring Equipment at STORM 07; Playa 3 in Background**

Permit-required monitoring at Storm Water Outfall 07 was conducted during the third quarter of 2010. Sampling included visual monitoring, pH evaluation, and metals. Visual examinations showed no abnormalities based on the visual criteria described in the MSGP. All metals were below IWQPs in 2010.
