For Calendar Year 2011

Site Environmental Report

Pantex Plant

Prepared for
U.S. Department of Energy/National Nuclear Security Administration
Pantex Site Office

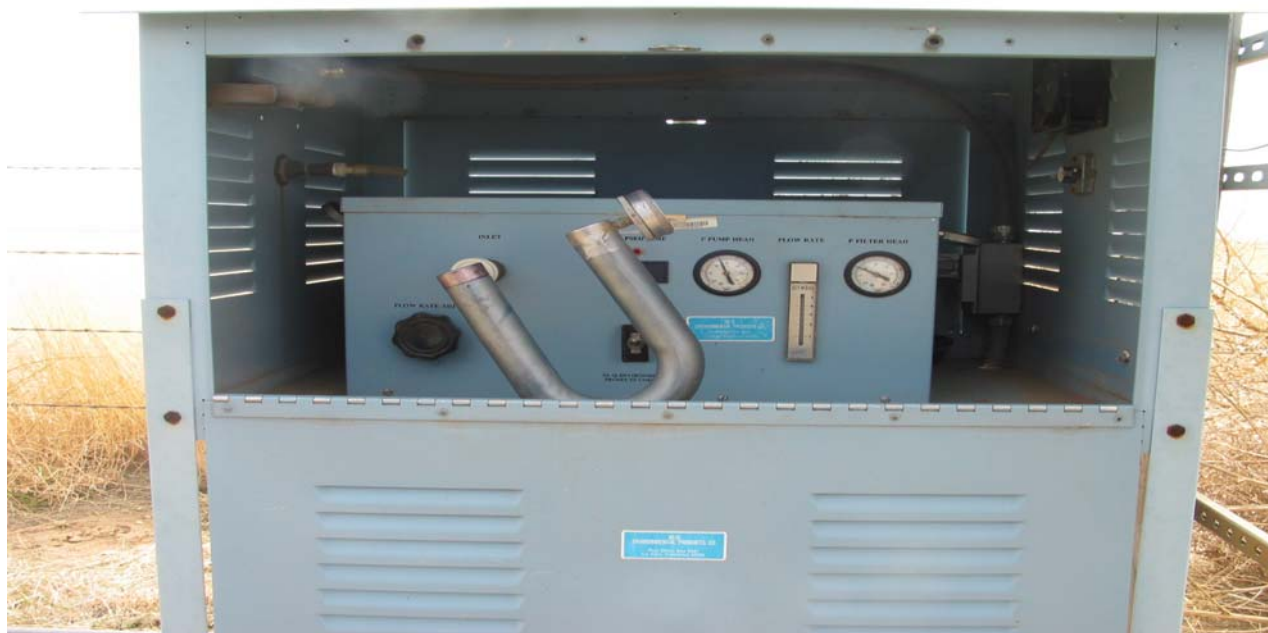
FIGURE 5.4 – Low-Volume Sampling Apparatus

Nominal airflow through the low-volume air samplers was much smaller than that for the high-volume samplers, being 42.5 liters per minute (1.5 ft³/min). Each low-volume sampler contained silica gel within the “U-tube” illustrated in Figure 5.4. The silica gel acted as a desiccant, removing water vapor from air as it flowed through the sampler. The silica gel samples were collected at the same time as the individual filters were collected from the high-volume samplers. Any tritiated water vapor present in the sampled air was recovered and quantified during analysis of the silica gel by a radiological analysis laboratory.

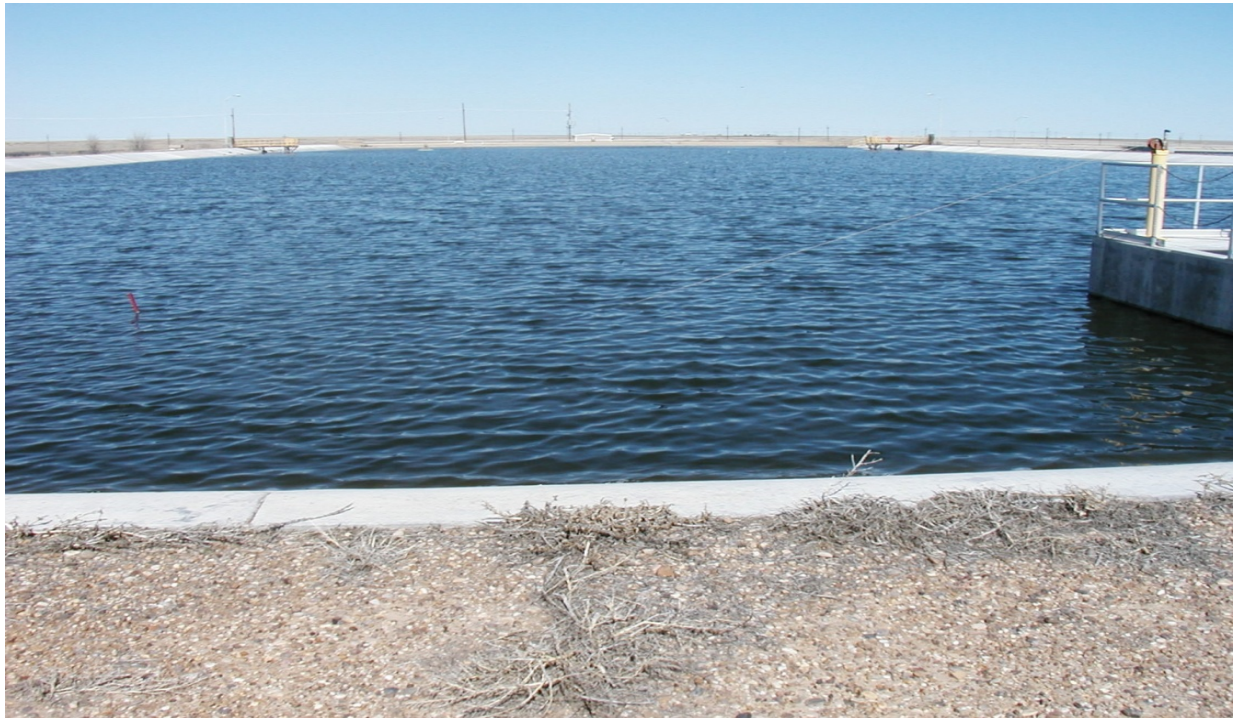
FIGURE 8.2 — *Wastewater Treatment Facility, Facultative Lagoon*

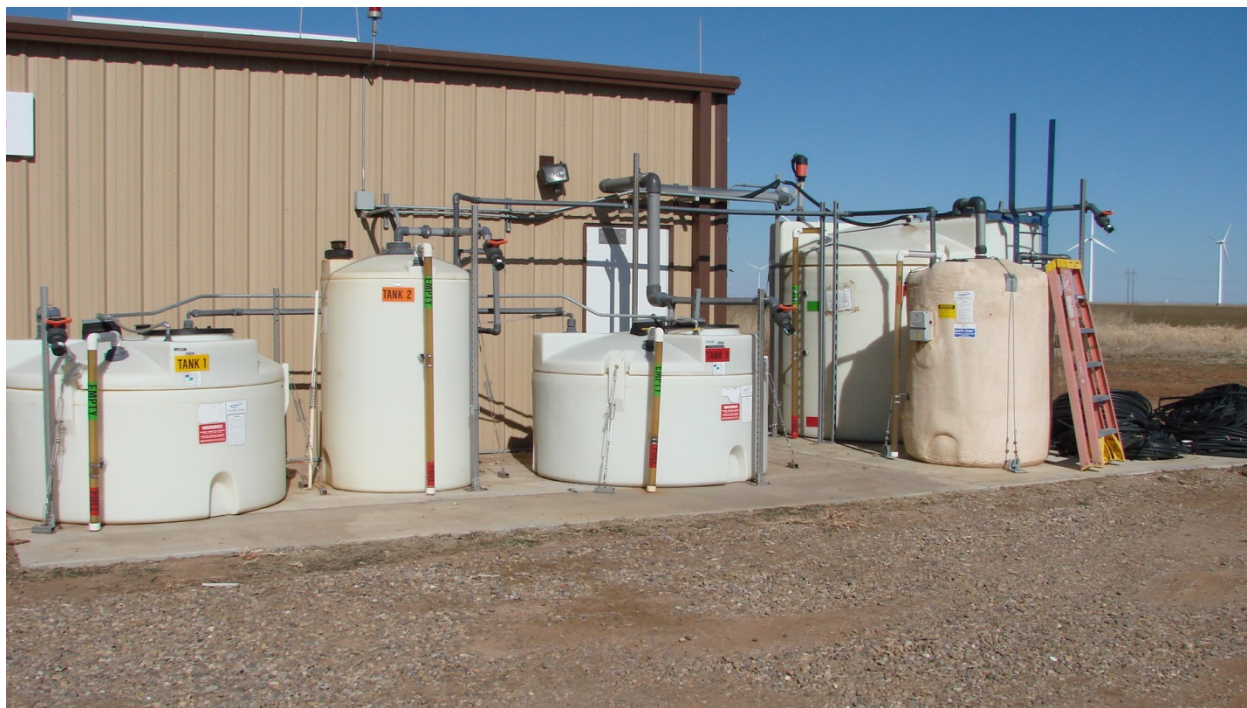
FIGURE 8.5 — Chemical Injection Tanks
