Long Term Stewardship Public Meeting

Manager of Environmental Projects
Consolidated Nuclear Security, LLC

Pantex Status

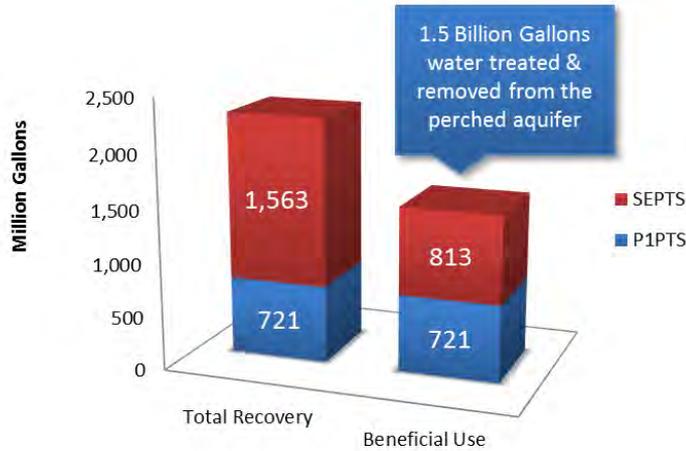
Total Recovery Since Startup

P1PTS & SEPTS	2015-2016 Total
Water Treated	>201 Mgal
Mass Removed (Cr+6, HE)	769 lbs
% Treated Water Beneficially Reused	99%

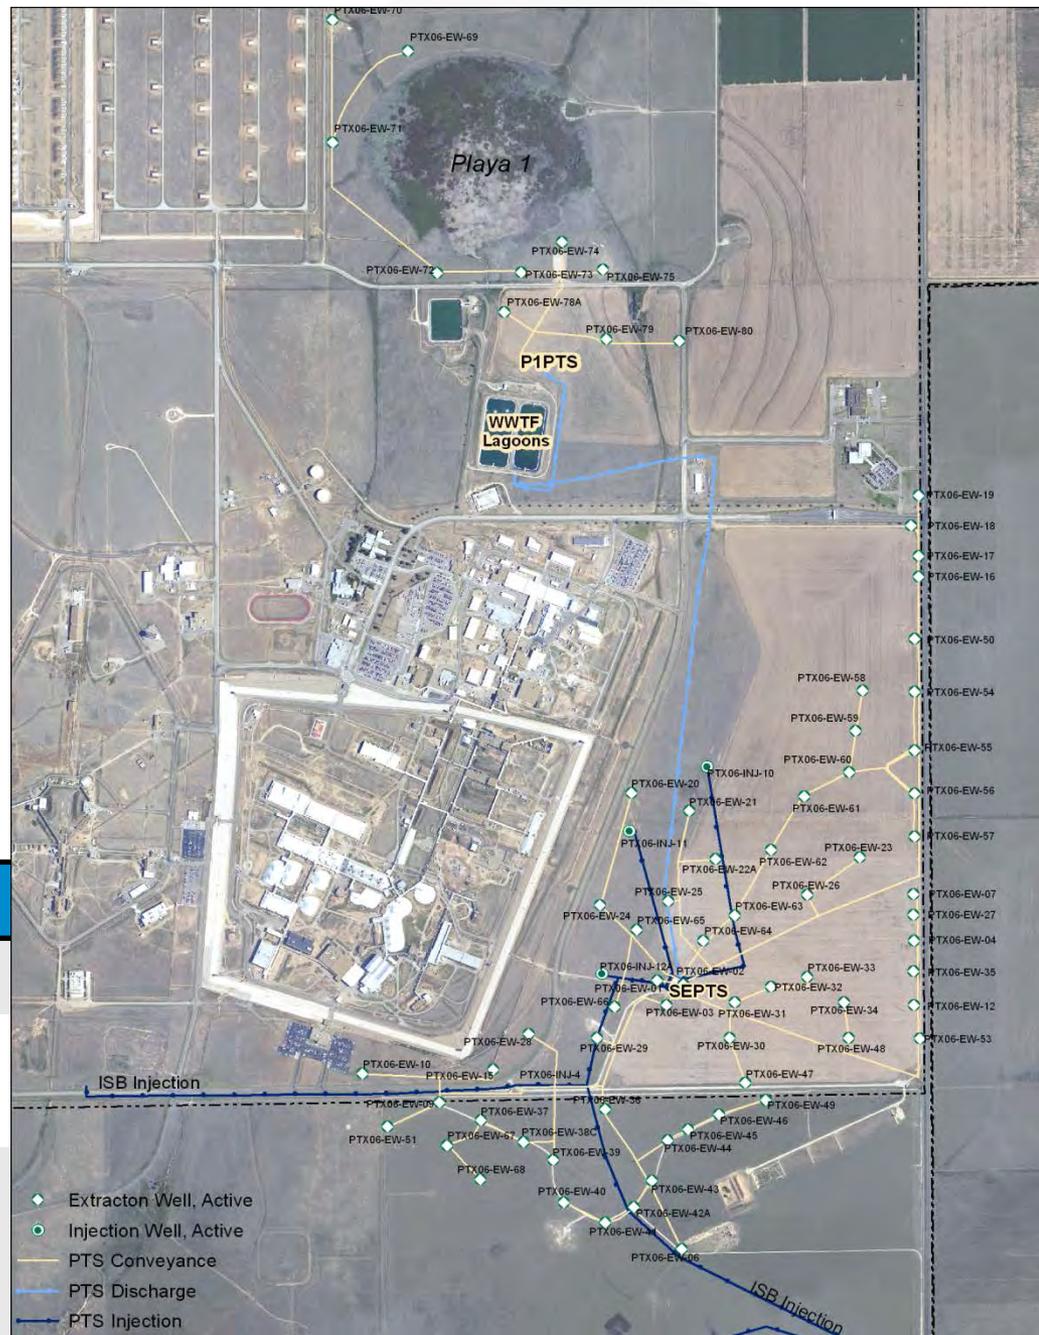
Pump and Treat Progress

Water levels declining

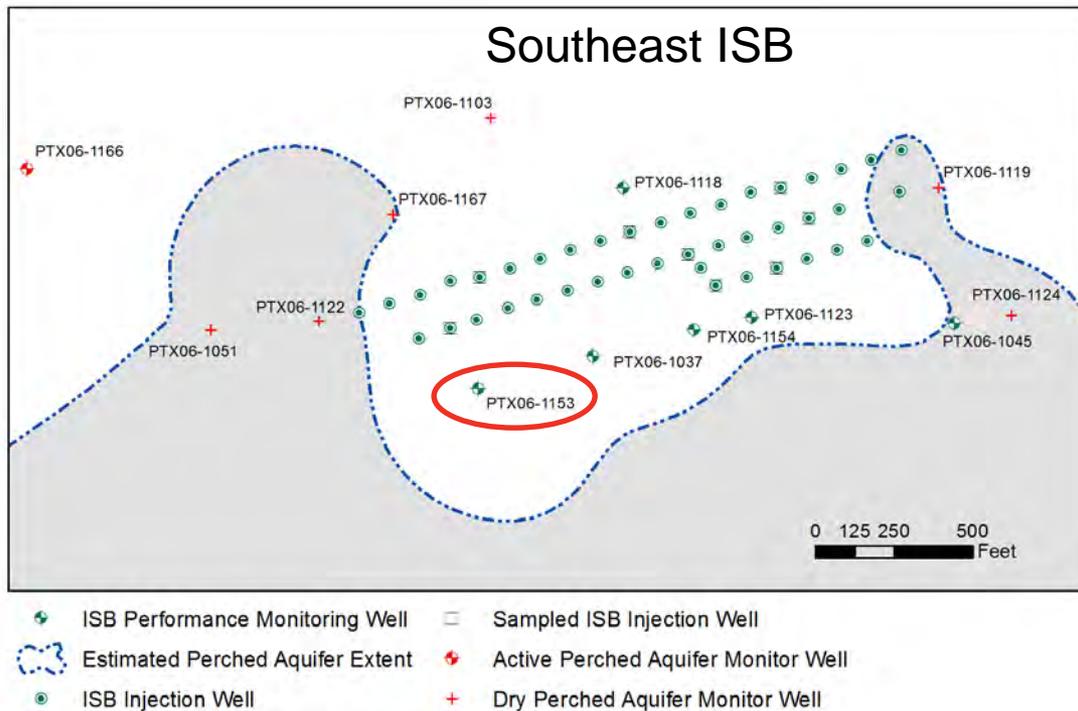
In-Situ Bioremediation Progress

System Treats:

- High Explosives
- Hexavalent Chromium
- 42 Injection Wells
- Water Levels Declining
 - 50% wells injected
 - PTX06-1123 no longer sampled (almost dry)

Criteria	Performance
HE Concentrations	< GWPS except at PTX06-1153
Cr+6 Concentrations	< GWPS except at PTX06-1153

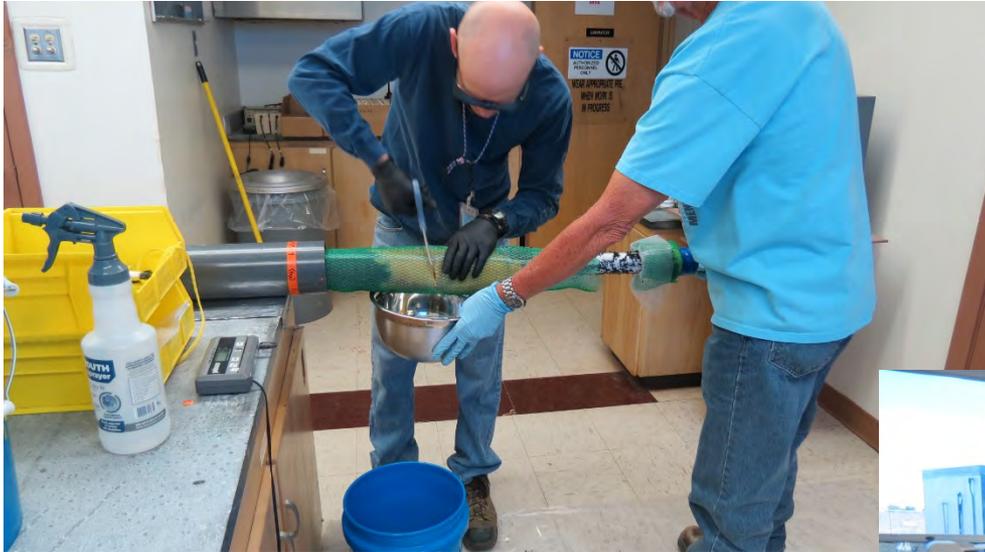
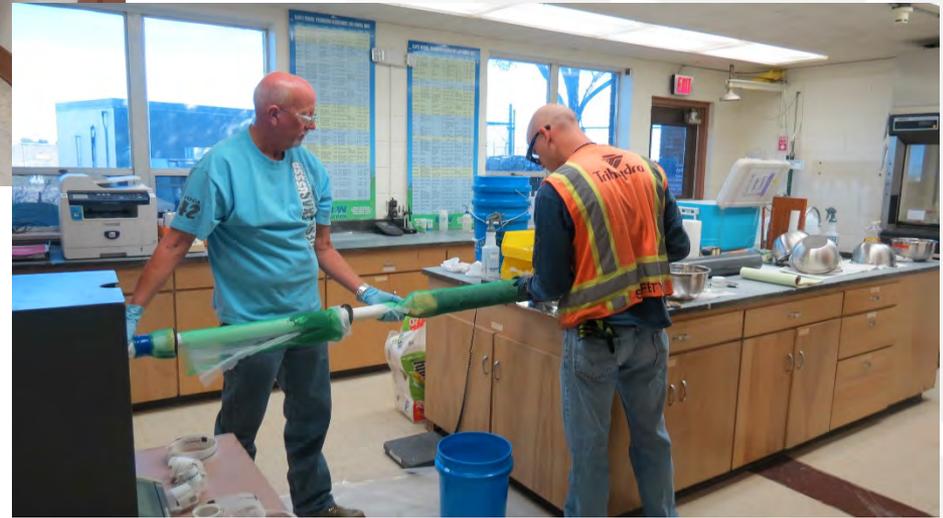
Passive Flux Meter Deployment

Fluxmeters deployed to determine if water and contamination is continuing to flux into the southeast area

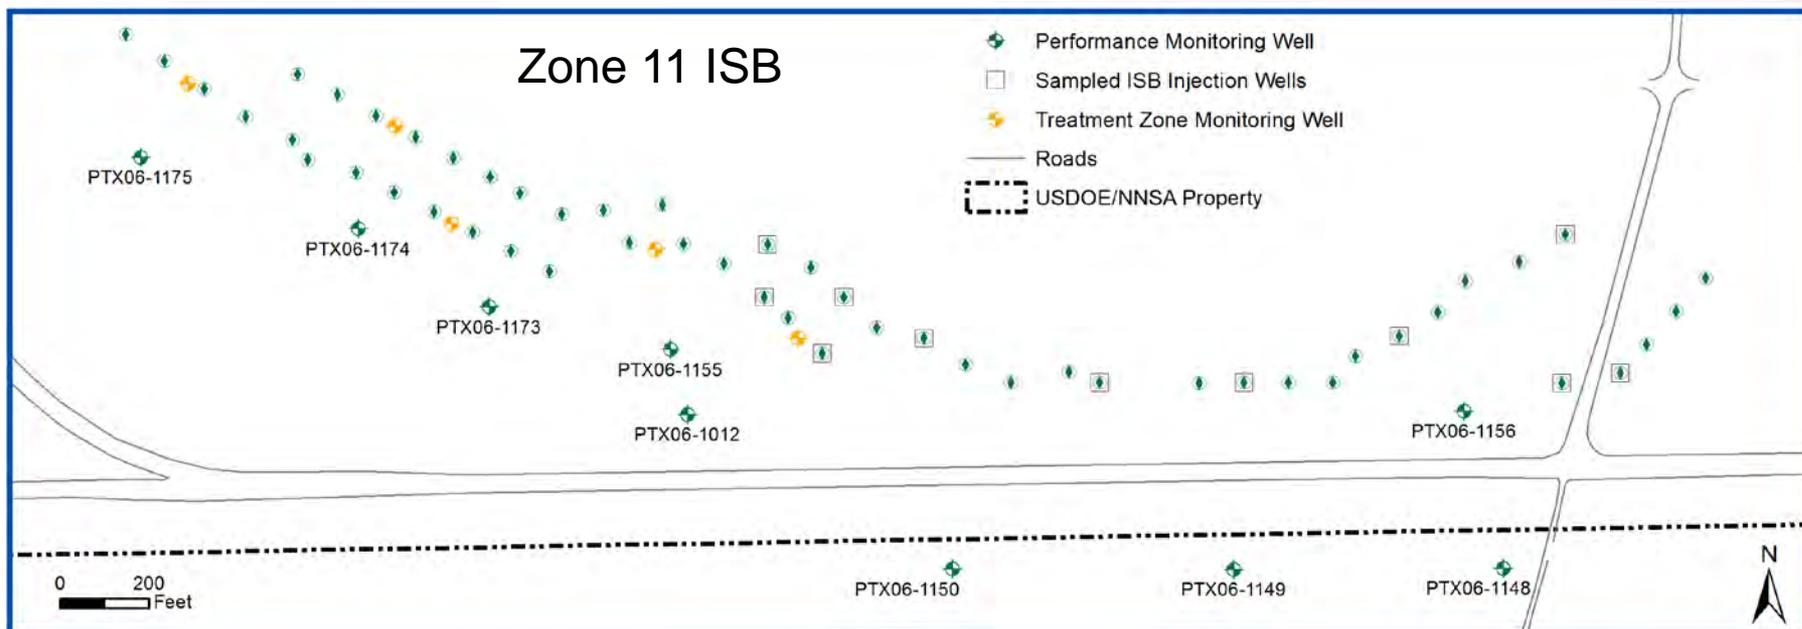
In-Situ Bioremediation Progress

System Treats:

- TCE
- Perchlorate
- 52 Injection Wells

Criteria	Performance*
TCE Concentrations	< GWPS at 4 of 6 wells
Perchlorate Concentrations	< GWPS at 4 of 6 wells
TCE Breakdowns	<GWPS at 4 of 6 wells

*New performance wells (1173, 1174, and 1175) not considered

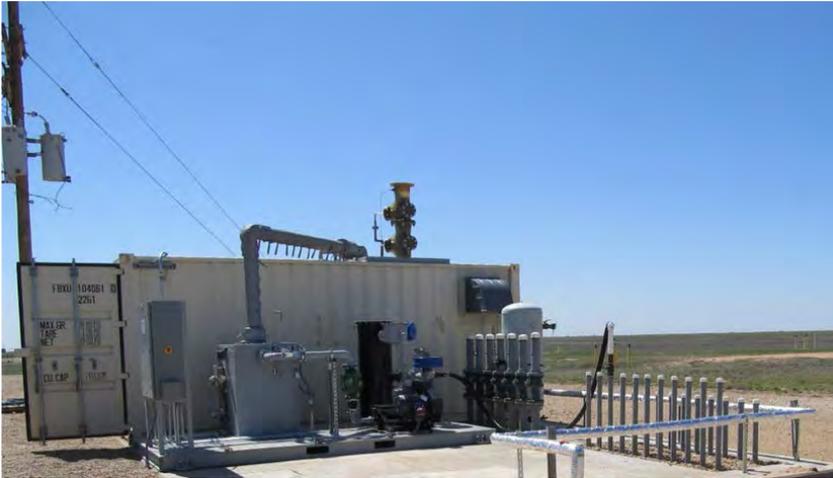
Burning Grounds SVE (Soil Vapor Extraction)

- System consists of a small catalytic oxidation (CatOx) treatment unit
- Extraction focuses on one well, SVE-S-20 near the source area

VOC Removal	lbs Removed
2015-2016	355
Since Startup	18,306

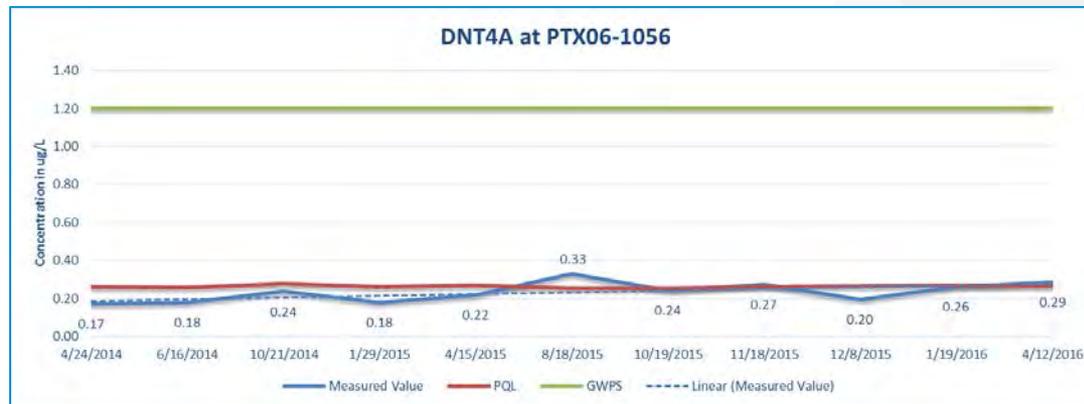
4-amino-2,6-dinitrotoluene Concentration Trend

- 4-amino-2,6-dinitrotoluene (DNT4A) continues to be detected at low concentrations
- Detections variable – slightly above/below PQL – all below cleanup levels
- 1,2-Dichloroethane (DCA12) continues to be detected below the PQL (1 ppb)
- Trends indicate a slight increasing trend for DNT4A and a decreasing trend for DCA12

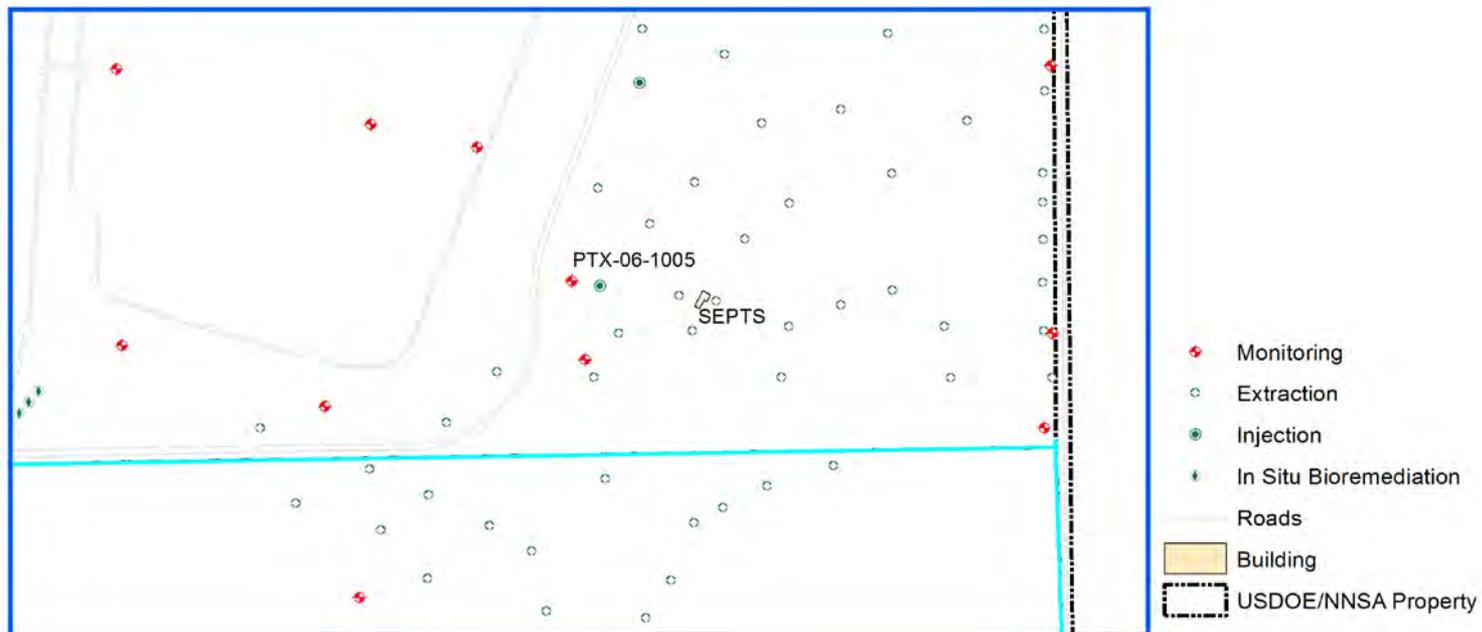
PTX06-1005 Unexpected Condition

- Detection of 1,4-dioxane at the cleanup level (7.7 ug/L)
- Resampled well to confirm results
- Well is on western edge of SEPTS extraction field
- 1,4-dioxane not treatable by current P&T methods
- Further monitoring of surrounding extraction wells will be added
