**Long Term Environmental Stewardship
Public Presentation**

2020

Pantex Overview

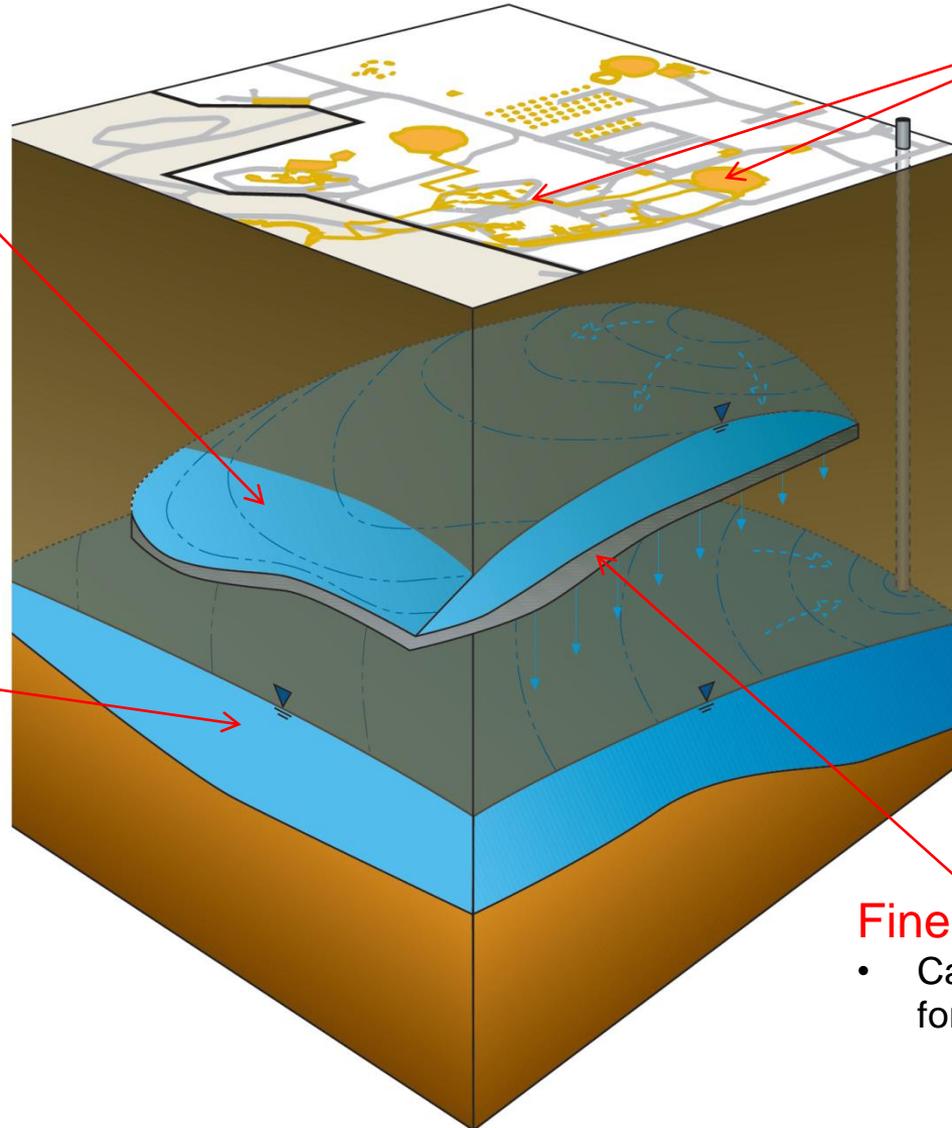
Groundwater Flow at Pantex

Perched Aquifer

- Depth: 200-300 ft bgs
- Saturated thickness: <1 to 75 ft (avg 15 -20')

Ogallala Aquifer

- Regional drinking water resource
- Depth: 400-500 ft bgs
- Saturated thickness ranges from 100-400 ft occurs 100-200 ft beneath perched aquifer

Playas/Ditches

- Past discharges of legacy wastes expanded our perched aquifer and contributed high explosive, solvents, perchlorate and chromium to perched groundwater

Fine Grained Zone (FGZ)

- Causes perched water to form

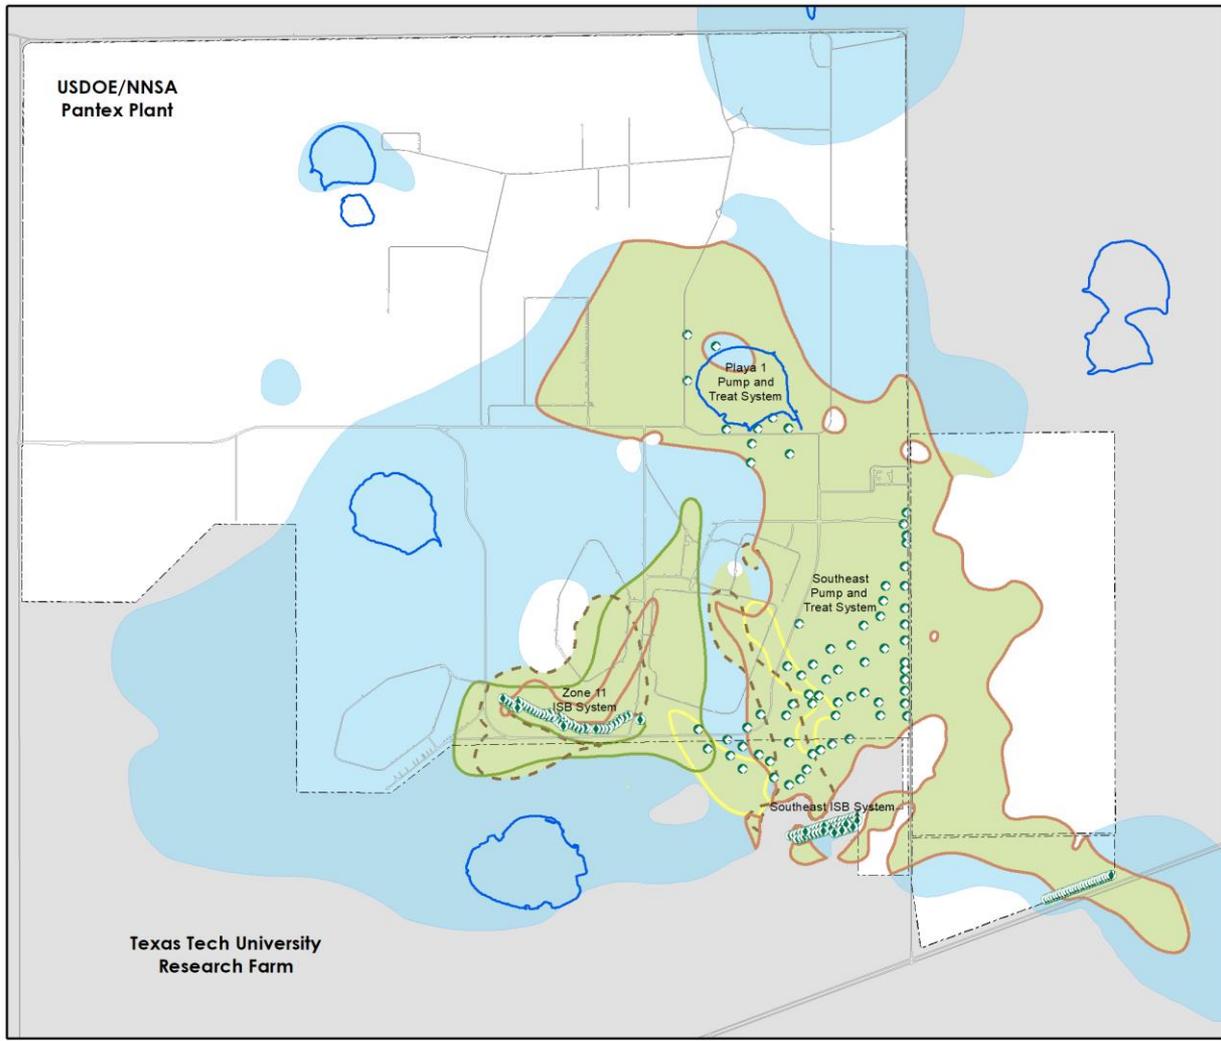
Groundwater Plumes at Pantex

- Perched Groundwater Extent as of Dec 2019
- Main contaminants:
 - RDX
 - High explosive
 - Hexavalent Chromium
 - Cr⁺⁶
 - Metal
 - Trichloroethylene
 - TCE
 - Solvent
 - Perchlorate
 - ClO₄⁻
- Mainly contained within DOE controlled boundaries; one area of migration offsite identified for action.

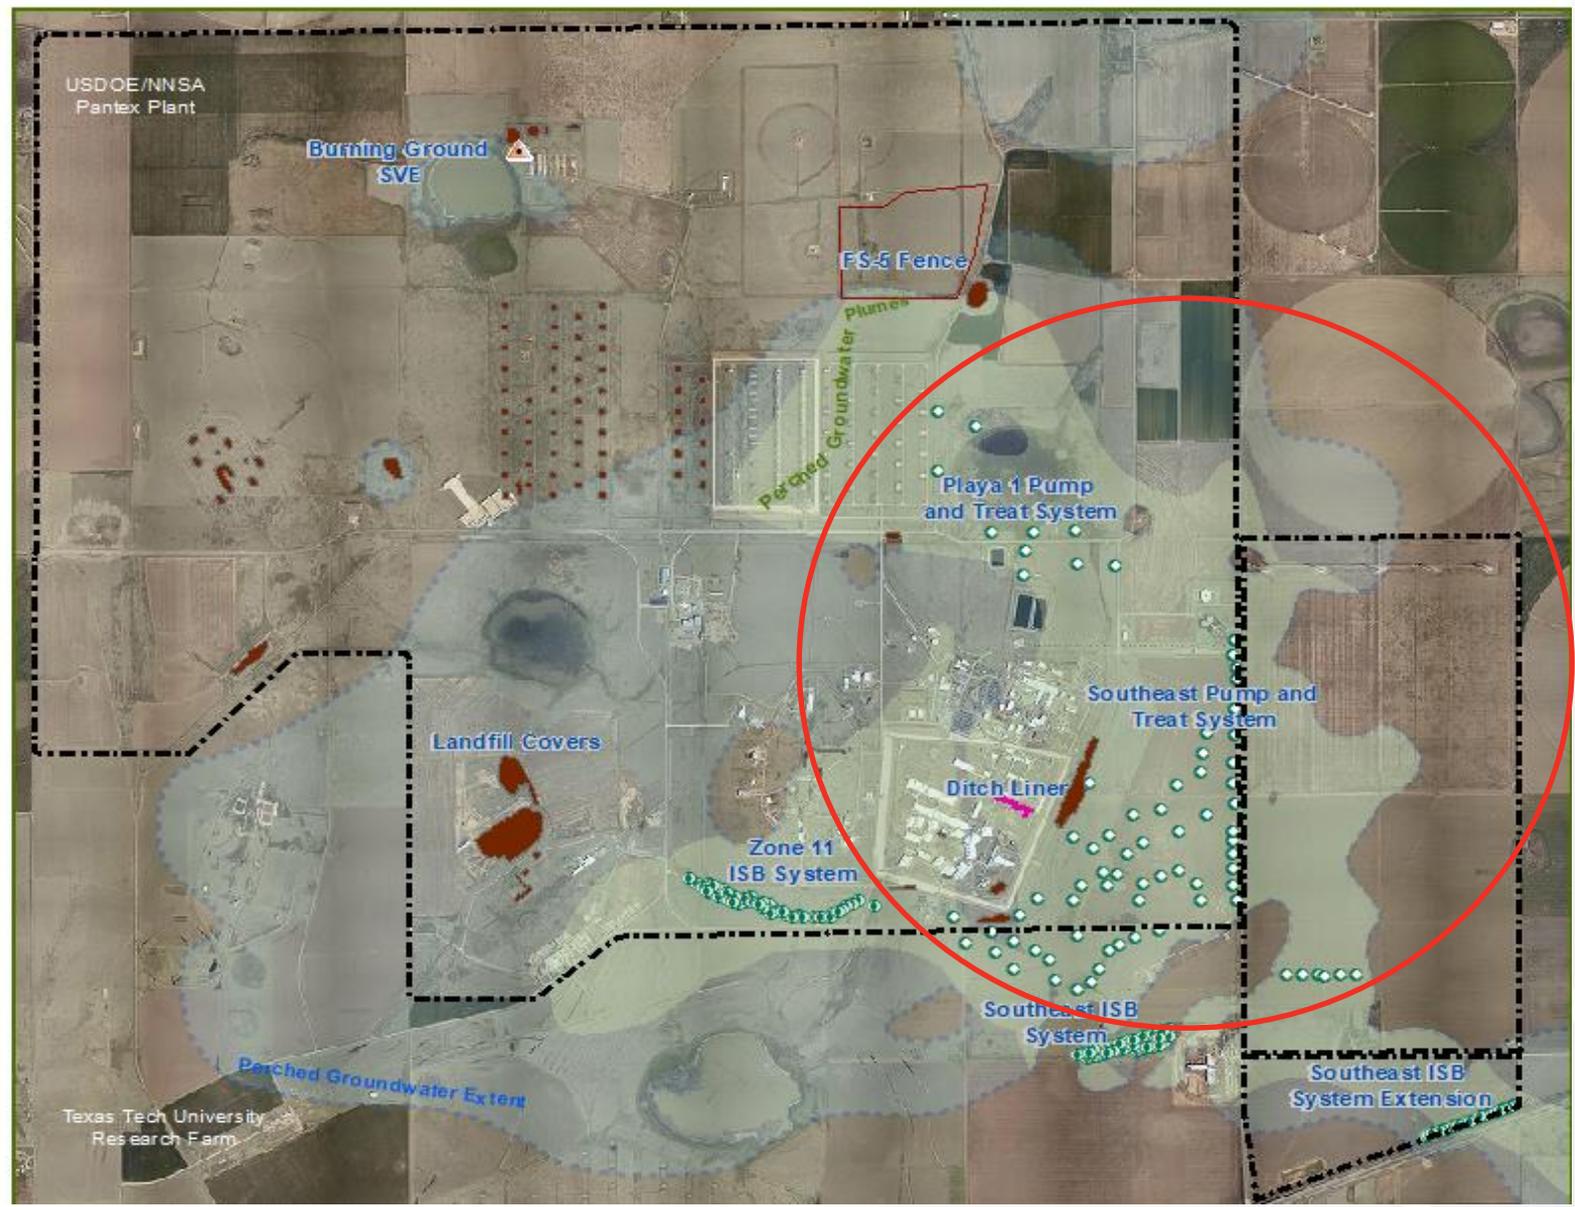
Pantex
Plant
Remedial
Action
Systems

Pump and Treat Systems

Two Systems:

- (1) Southeast Pump and Treat (SEPTS)
 - Intercepts plumes/contamination and removes water
- (2) Playa 1 Pump and Treat (P1PTS)
 - Reduces water mounding

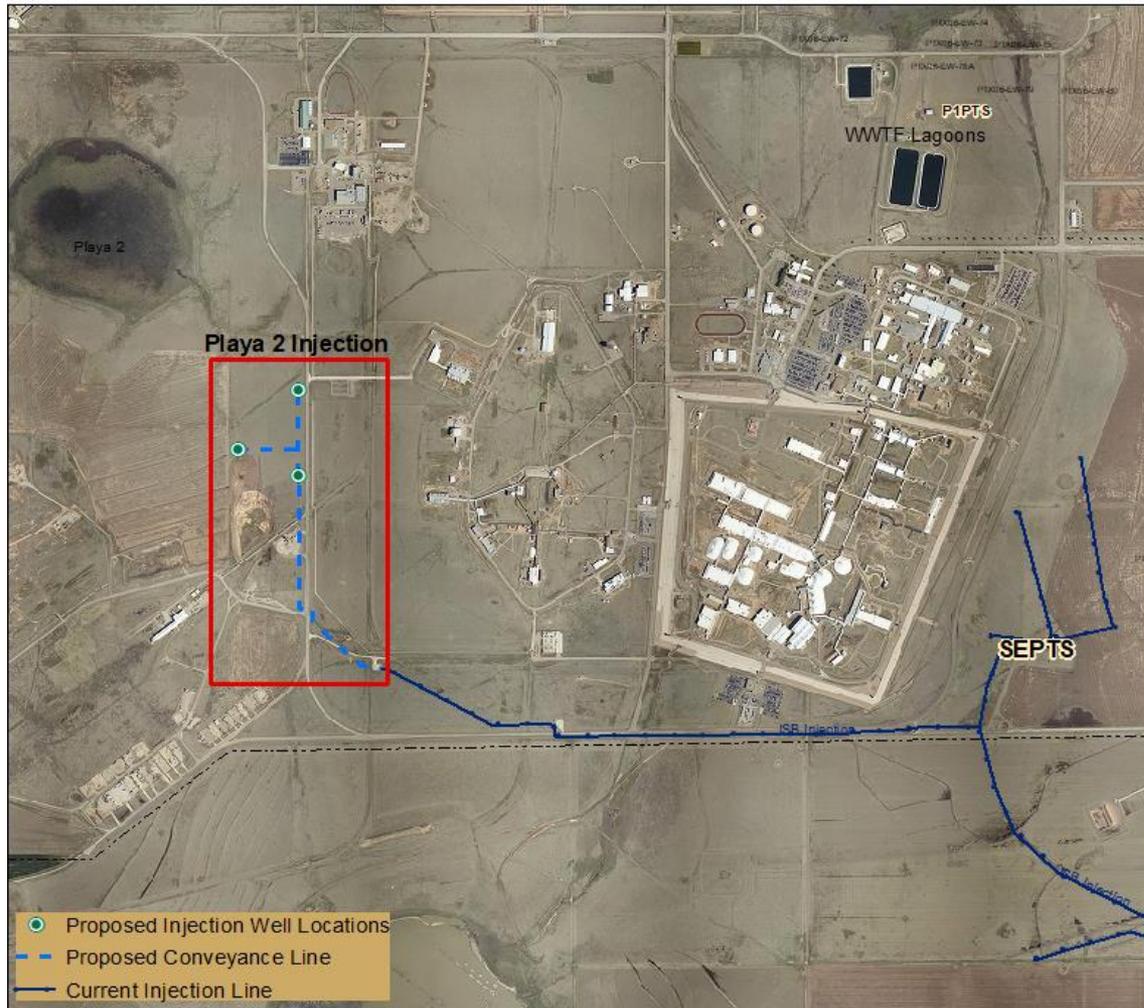
SEPTS Expansion: Playa 2 Injection

Milestones:

- Completed design in Dec 2019
- Began construction in Feb 2020
- Completing construction in Nov 2020

System Components:

- 3 injection wells, 150 gpm, subsurface conveyance line and booster pump
- SCADA system to communicate with SEPTS

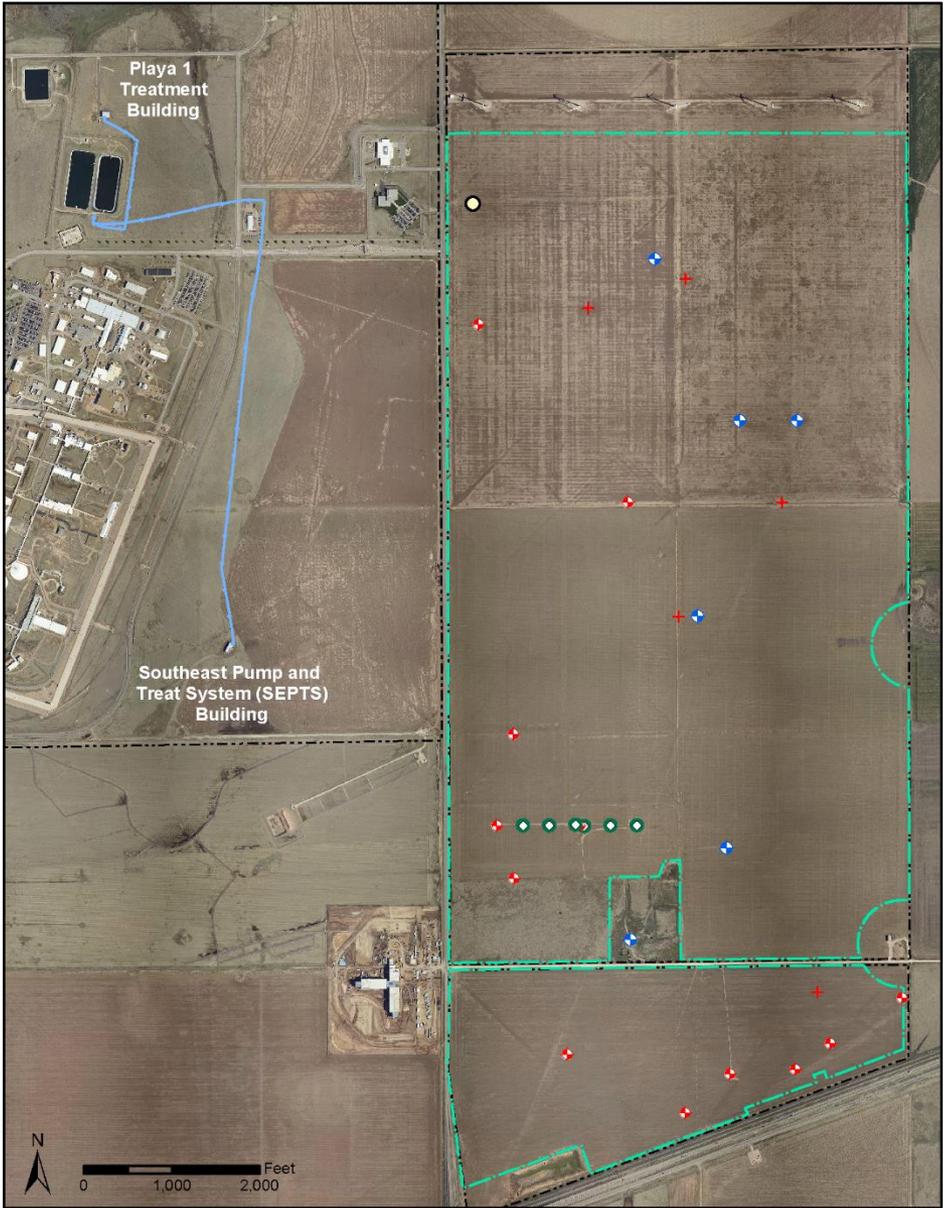
Site Layout for the Pivot Sprinkler Design Project

Pivot Sprinkler East of FM 2373

System Components:

- 3 – 6 pivot sprinklers, subsurface conveyance line and booster pump
- SCADA system to communicate with SEPTS and P1PTS

Well Type	
● Perched Extraction	◆ Ogallala Wells
◆ Perched Monitoring	○ East TLAP Outfall
● Perched Dry Well	— Treated Effluent Conveyance
	□ East TLAP Boundary

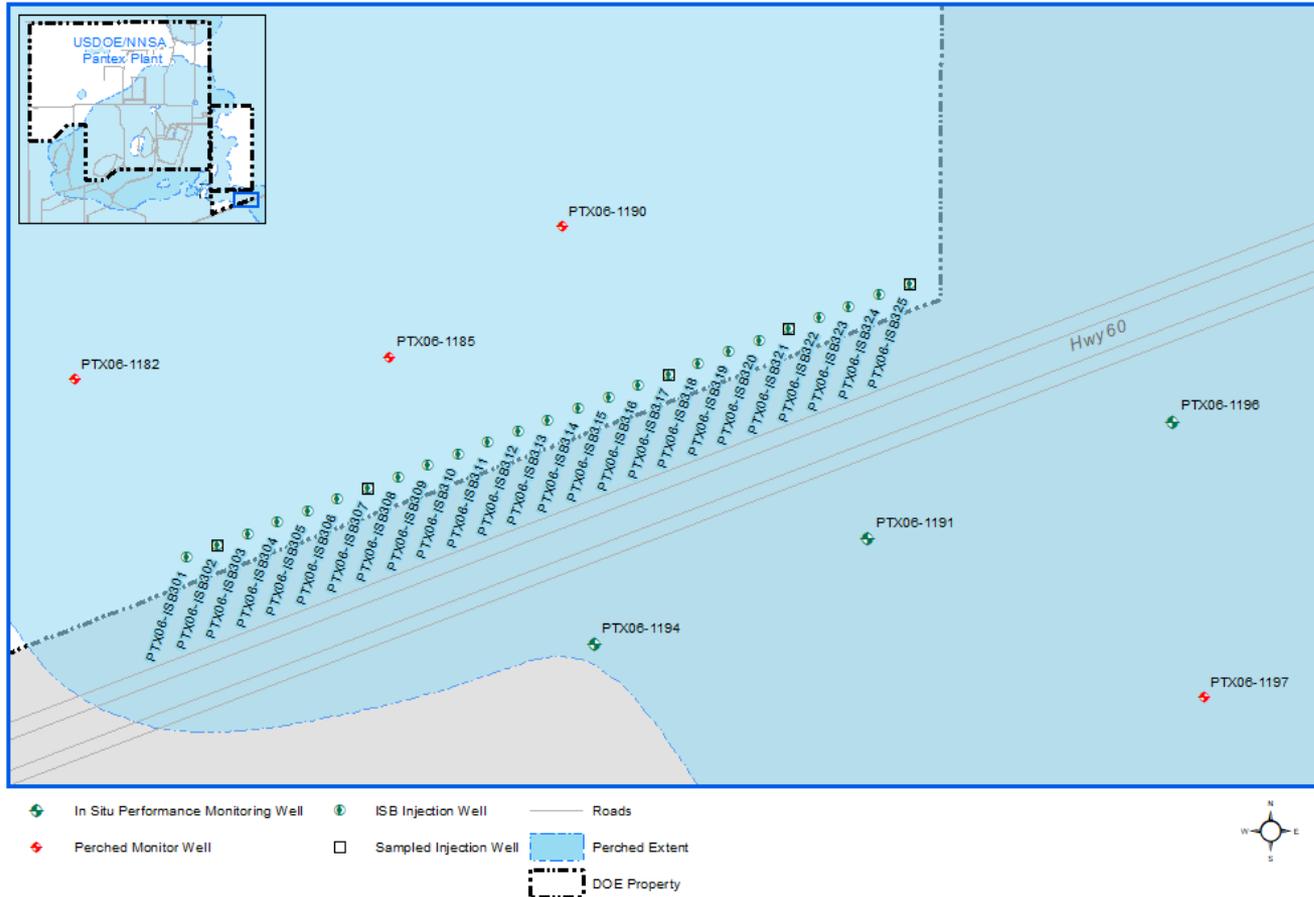
Southeast Extension ISB

System Information:

- Main contaminant – RDX
- Installed in 2018
 - 25 injection wells
 - 3 performance monitoring wells
- Positioned to treat the contaminants in the southeast plume moving to offsite landowner property
- First 2 injections occurred in 2019 (February and September)
- Degradation of RDX is not expected to occur until late 2021
- Molasses is only amendment used currently at this system

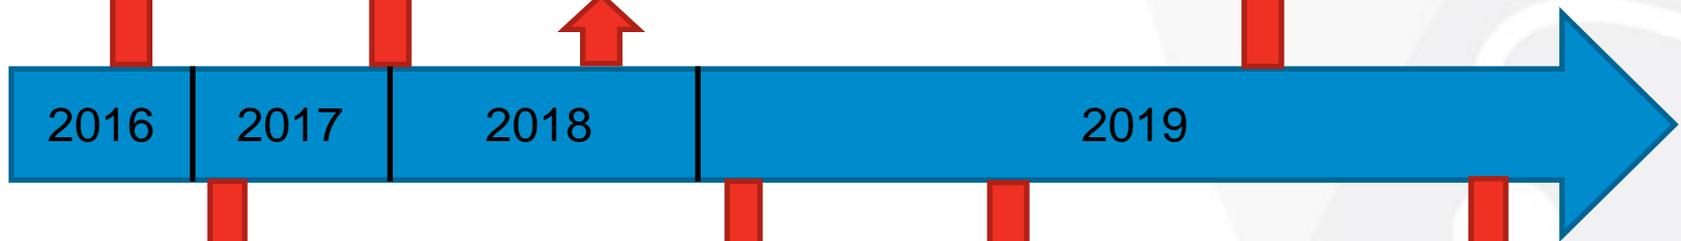
Timeline to Execution of Offsite System

2016:

Observation of Southeast Moving Plume

2017/2018:
Plume Extending Further SE

2018: Installed 25 injection wells to remediate/cutoff plume (SE-Ext ISB)

2019: 2nd Injection into SE-Ext ISB

2019: 1st Injection into SE-Ext ISB

2019: Addition of monitoring wells on neighbors property to define extent

2017: Pump and treat wells are added east of FM 2373 to SEPTS system to reduce impact of water movement to SE

2019: Optimization/modeling of new system to right-size the remedy is completed and remedy is selected

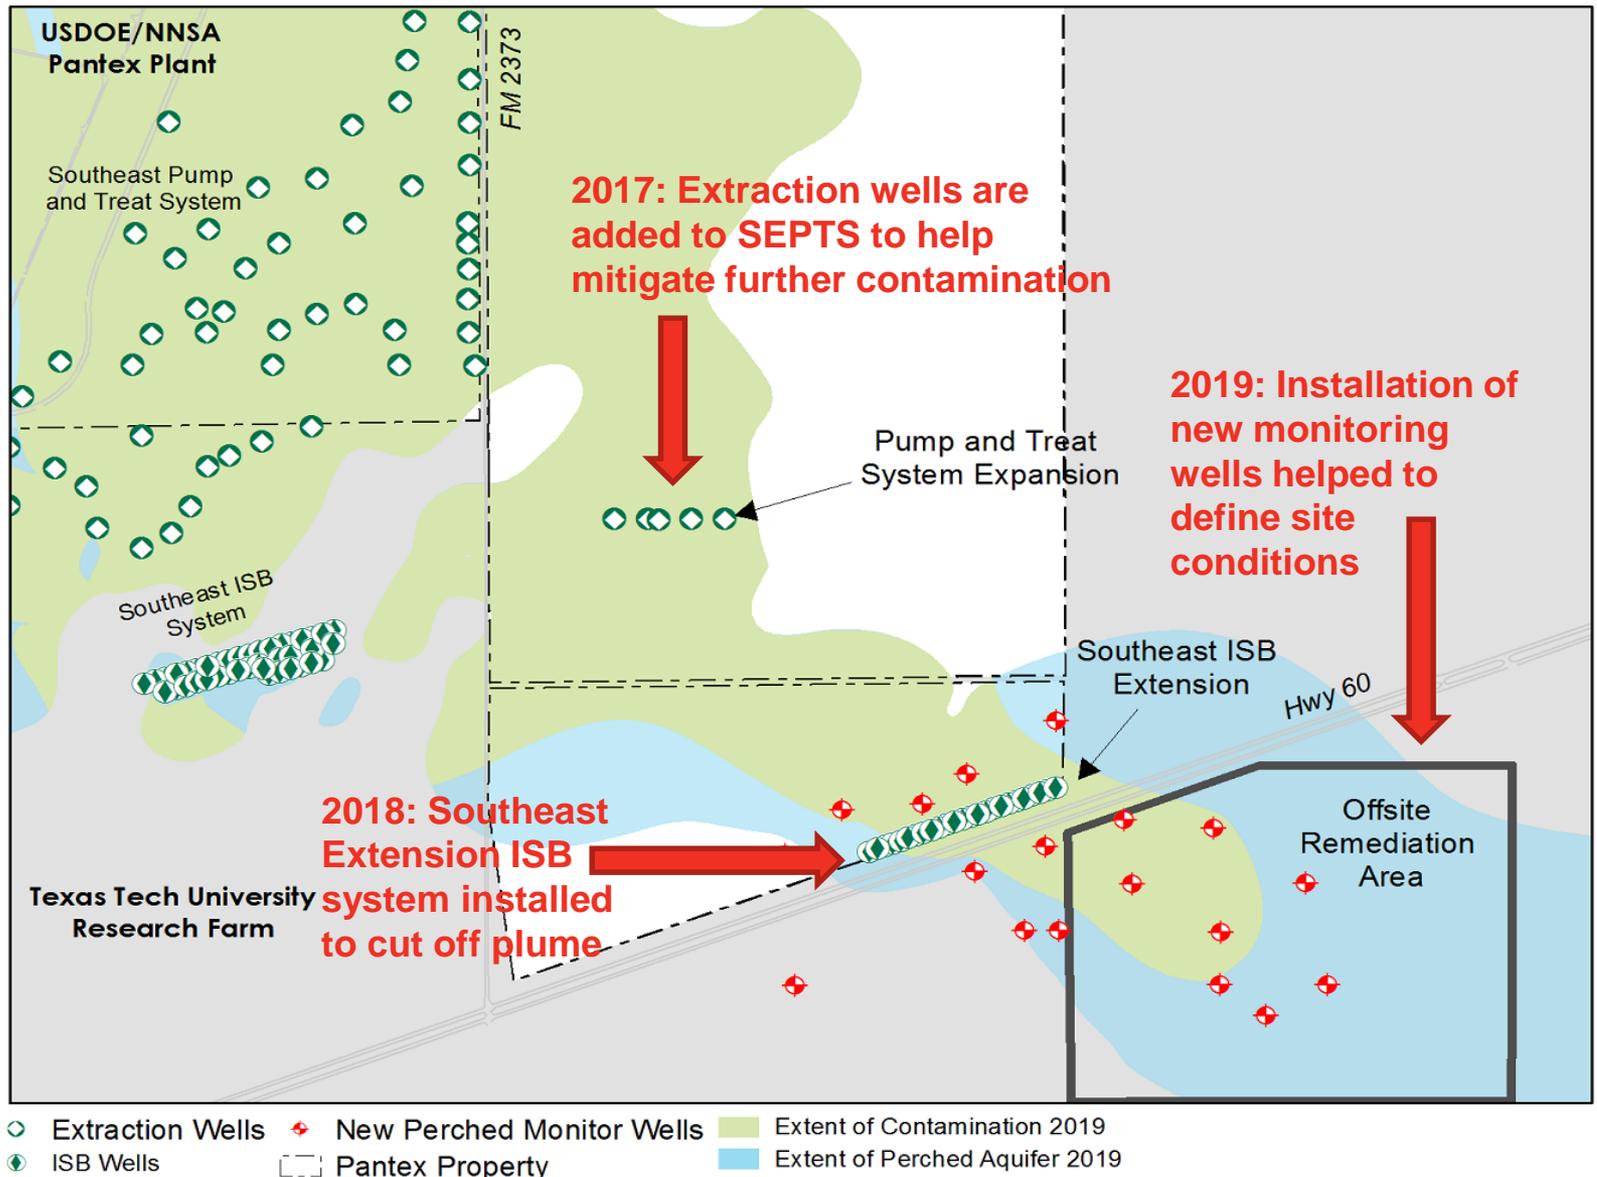
Offsite ISB System as of October 2020

Pantex Offsite Treatment Area
Well Types and Locations

*Phase 1 (Oct 2019 – Jun 2020):
Installation of 10 ISB injection
wells, 4 ISB extraction wells*

Wells were placed to address
leading edge of the plume.
Further expansion of plume is
cut off.

*Phase 2 (Jul 2020 – Sept 2020):
Originally planned for 2021 but
worked with contractors to
expedite project during COVID-19
Installation included 6 ISB
injection wells, 7 ISB extraction
wells, 3 pump and treat extraction
wells*

- Extraction Wells
- ISB Wells
- ISPM Wells
- Monitoring Wells
- Neighbor Property 1
- Neighbor Property 2
- DOE Property

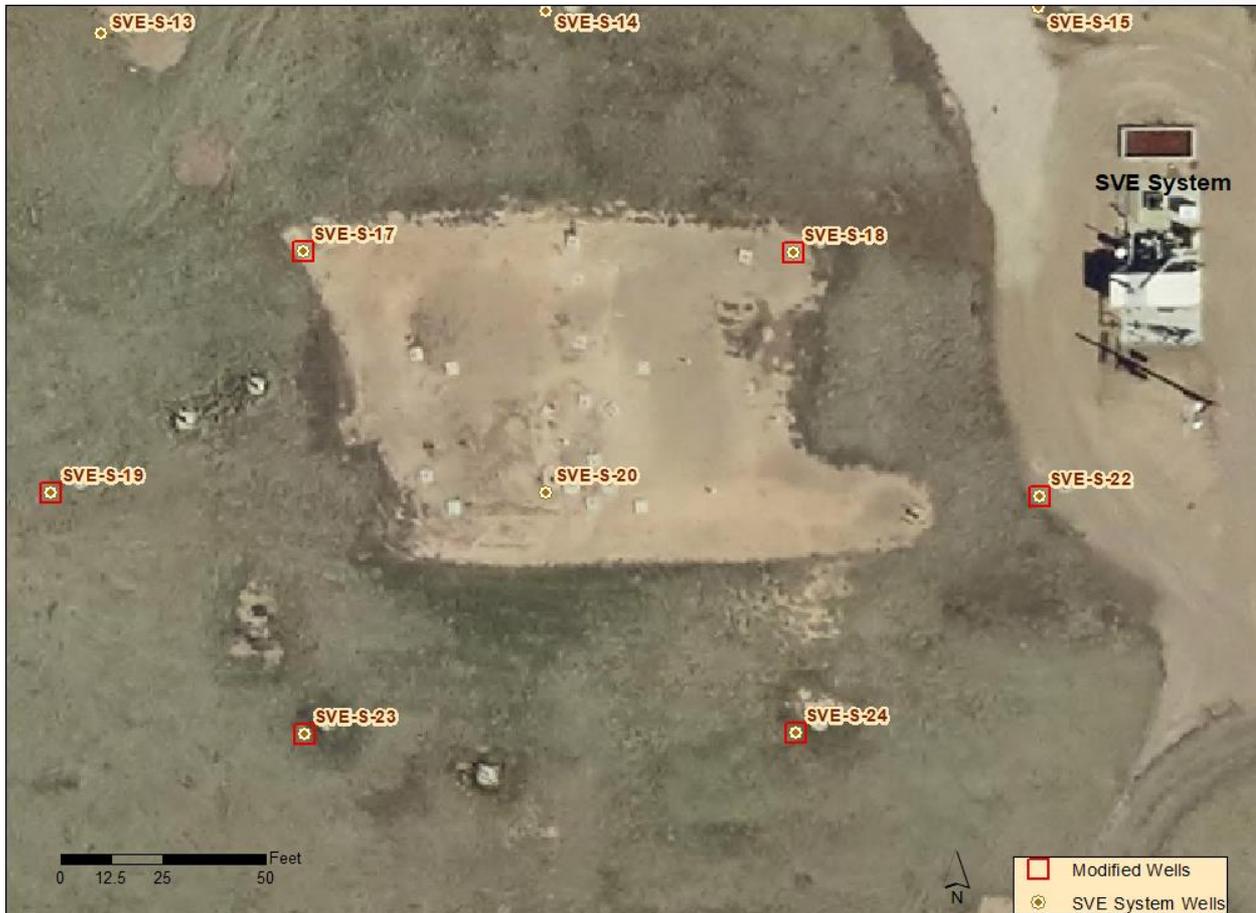
Soil Vapor Extraction System

Installed in February 2002

- Remedial goal to reduce the mass of Volatile Organic Compounds (VOCs) – highest historical concentration ~ 1845 ppmv; highest current concentration ~ 100 ppmv

System Information:

- Large-scale catalytic oxidation originally
- System transitioned to:
 - Activated carbon drums
 - Smaller blower motor for extraction
- Later replaced by more cost efficient small scale CatOx system (current system)
- Modified in May 2017 to increase air flow

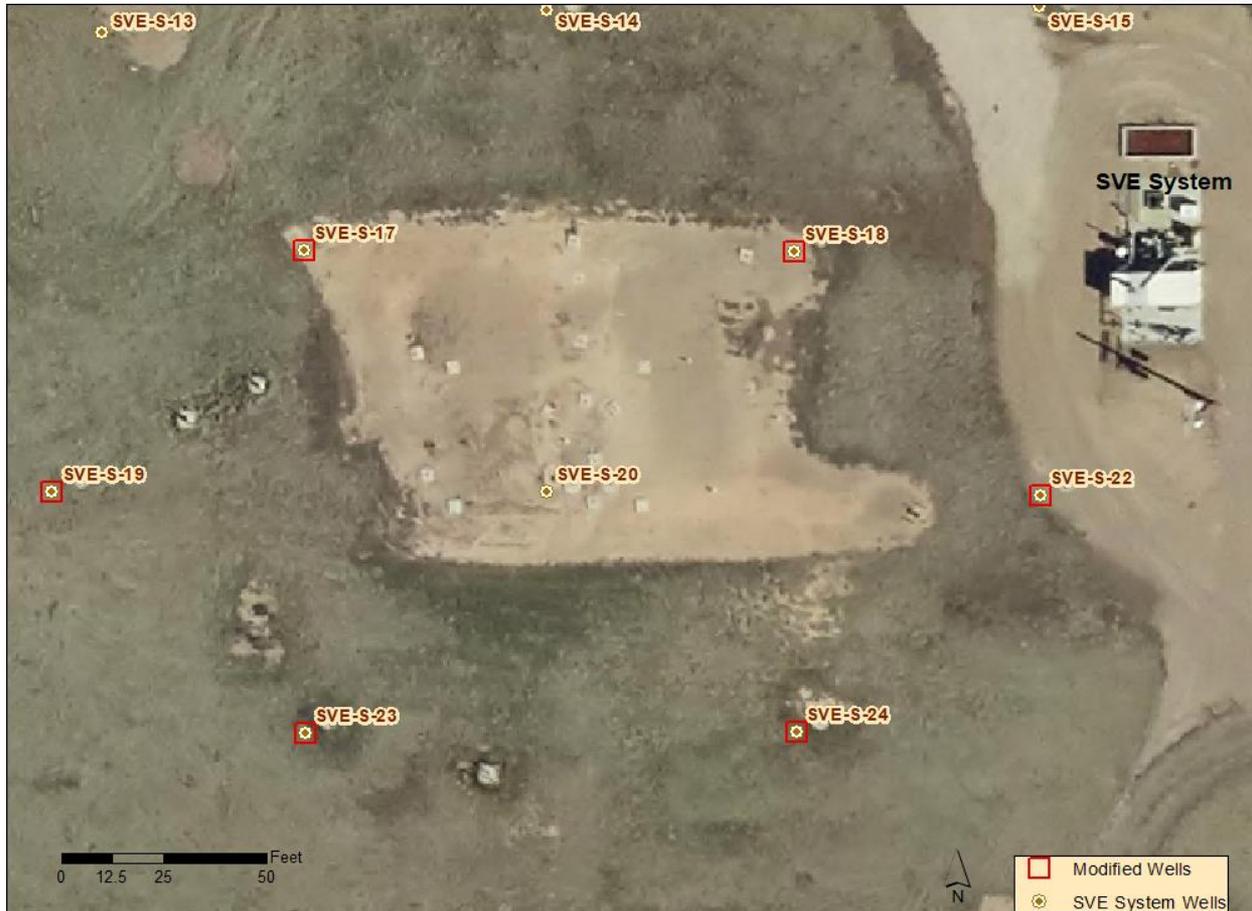
Soil Vapor Extraction System

Accomplishments: (July 2019 – June 2020)

- Removed 214 lbs of volatile organic compounds

Total VOCs removed since startup:
21,035 lbs
