For Calendar Year 2020

Annual Site Environmental Report

Pantex Plant

Site Environmental Report Pantex Plant 2020

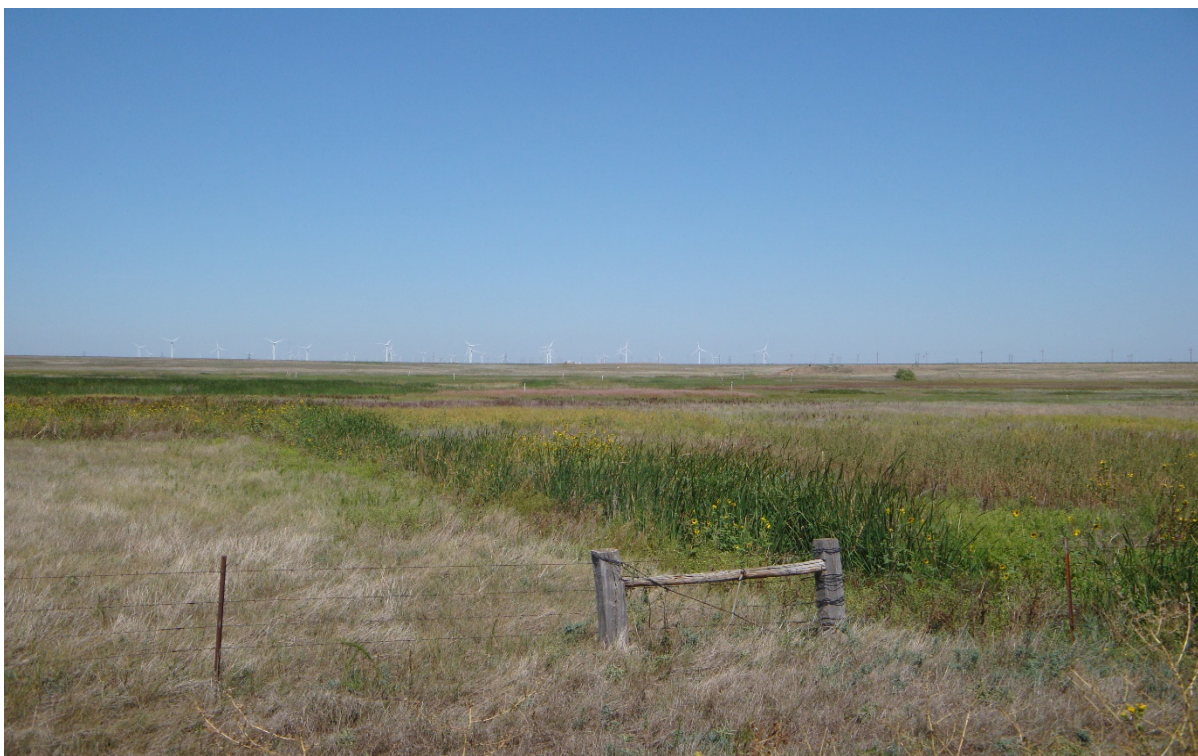
Figure 8.1 – Playa 1

Domestic and industrial wastewaters generated at Pantex Plant are treated at an on-site WWTF. Industrial effluents from Pantex Plant operations are generally pre-treated and directed into the WWTF for further treatment. All such effluents are collected in the sanitary sewer, managed in the WWTF, and can be discharged through permitted outfalls to either an underground irrigation system or an on-site playa lake. The playa is an ephemeral lake and is not connected to any other lakes, rivers, or streams (Figure 8.1).

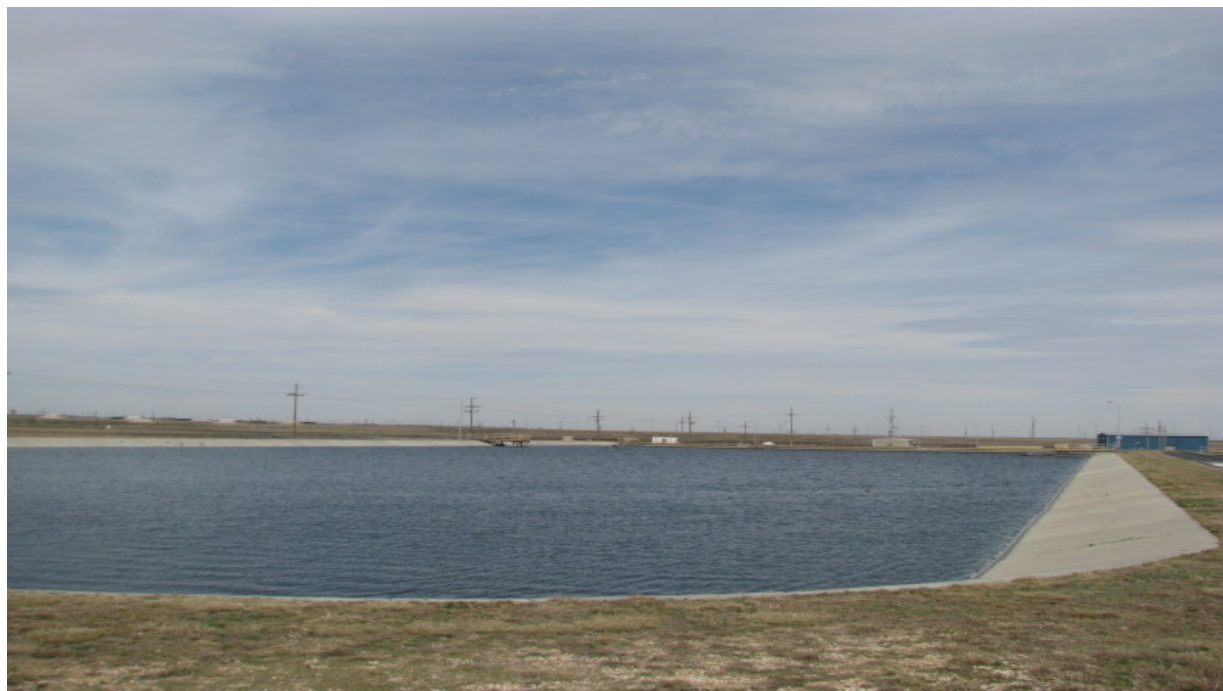
Figure 8.2 – Wastewater Treatment Facility, Facultative Lagoon

The treatment process in the facultative lagoon involves a combination of aerobic, anaerobic, and facultative bacteria. At the surface, aerobic bacteria and algae exist in a symbiotic relationship. Oxygen is provided by natural aeration processes, algal photosynthesis, and by solar-powered mechanical aerators. Bacteria utilize the oxygen for the aerobic degradation of organic matter, while algae utilize the nutrients and carbon dioxide released in the degradation process. Facultative bacteria within the water column are used in the treatment and degradation of organic matter. Anaerobic bacteria decompose organic matter that is deposited in a sludge layer at the bottom of the lagoon. The wastewater treatment process in a facultative lagoon is complex and nearly all treatment is accomplished by biological activity.

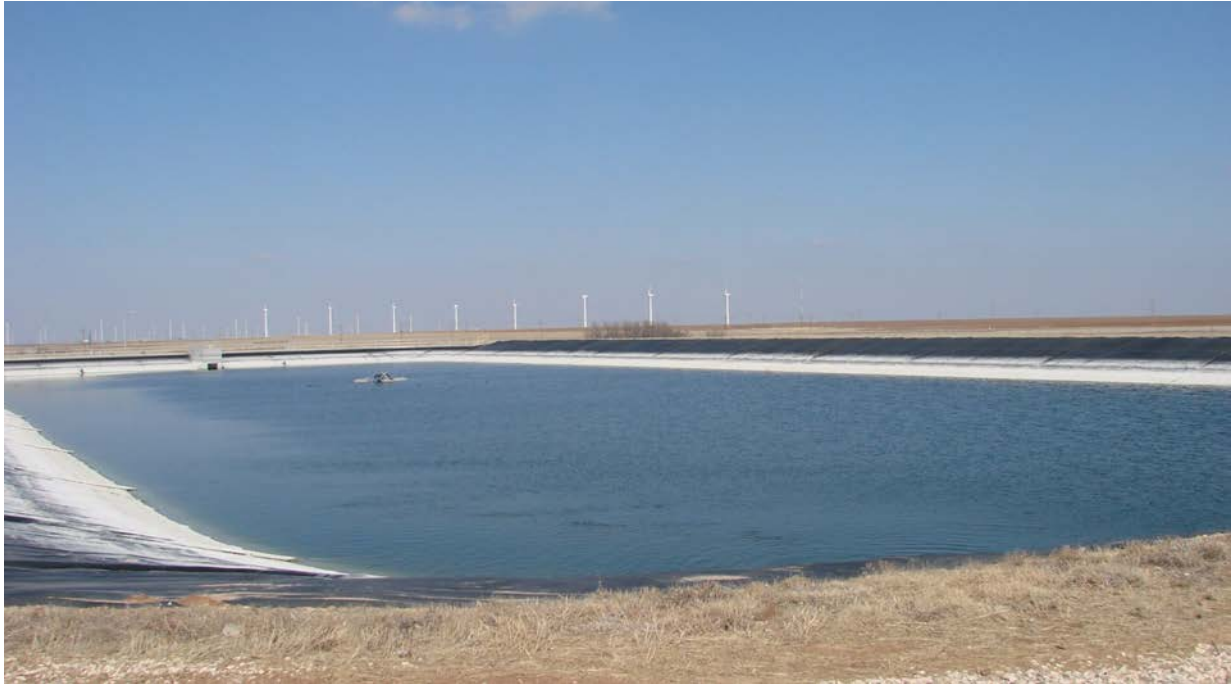
Figure 8.3 – East Wastewater Storage Lagoon

The WWTF (Figure 8.2) is a clay-lined, facultative lagoon that covers approximately 3.94 acres (ac) and has a capacity of 11 million gal. In addition to the WWTF, there are two storage lagoons (Figure 8.3 and 8.4) that are utilized for the storage and retention of treated wastewater. The east lagoon (Figure 8.3) is a storage lagoon that is lined with a polyethylene liner and has similar dimensions and capacity to the facultative lagoon. This lagoon receives treated domestic and industrial wastewater, as well as treated

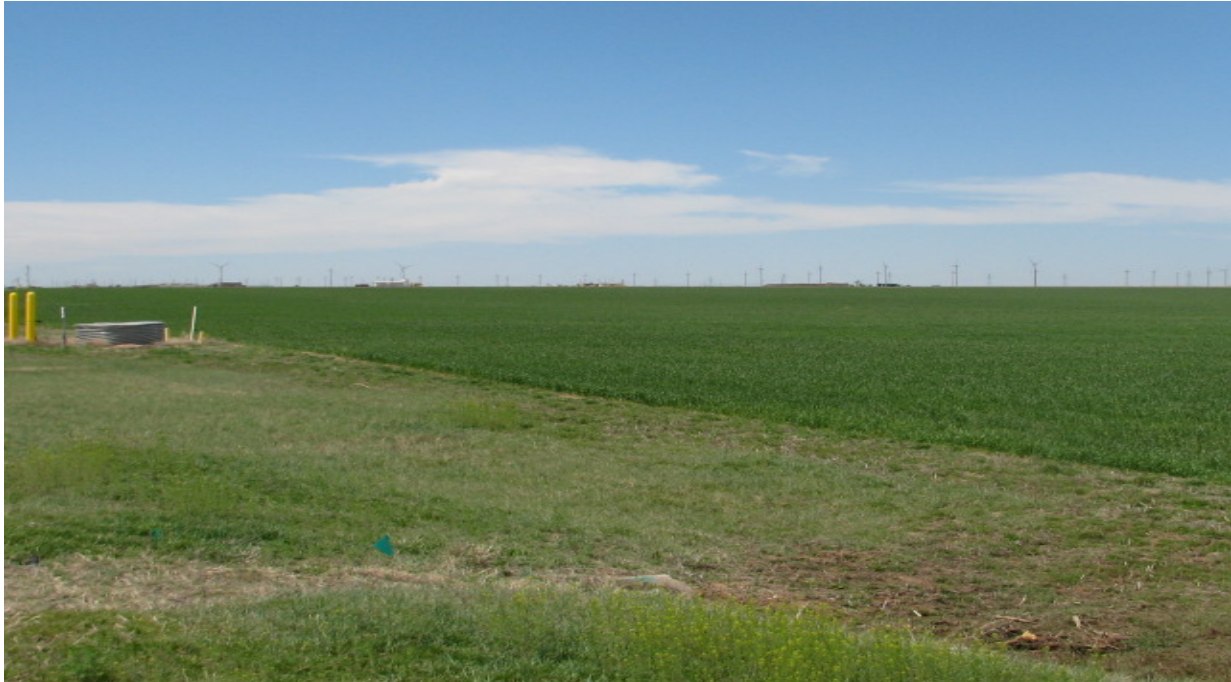
Figure 8.5 – Irrigation Tract 101

Under the Texas Land Application Permit (TLAP), WQ0004397000, Pantex Plant is permitted to dispose of treated wastewater by means of a subsurface irrigation system into agricultural fields for beneficial reuse (Figure 8.5). This permit was modified and reissued on August 11, 2020, and will expire on August 11, 2030. When discharging to the subsurface irrigation system, water is distributed through manifold pipes to individual zones located within four tracts of land that are each approximately 100 acres (ac) in size.
